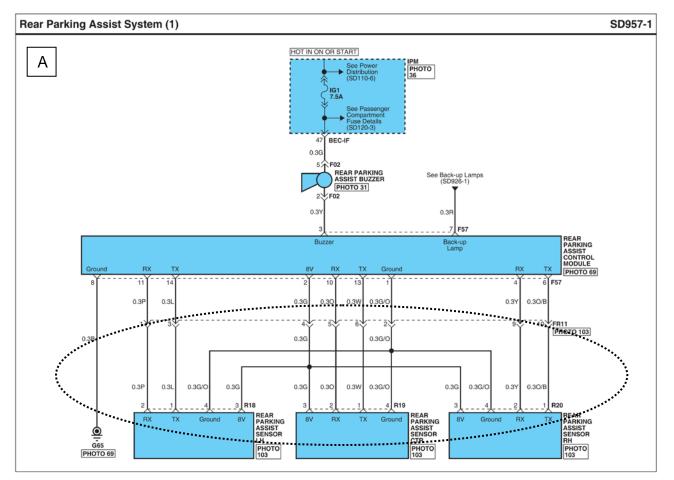
If you encounter a customer complaint relating to the audible tone from the back-up assist feature remaining on at all times, inspect the sensors in the rear bumper for possible collision damage causing a short in the sensor. Also, make sure to check the harnesses feeding the sensors for continuity to ground. Refer to the schematic diagram (A) below or to the <u>Body</u> <u>Electrical</u> section of the service manual for detailed repair information.
