Reference	SSM60517
Models	Range Rover Sport / L320 LR3 / L319 LR4 / L319
Title	Steering Gear O-ring Fluid Leaks
Category	Chassis
Last modified	07-Aug-2013 00:00:00
Symptom	303000 Steering/Handling
Content	<p>Issue: Following warranty analysis of Steering Racks reported to be leaking, 75% have been identified being fault free, following testing.</p> <p>Cause: Land Rover Engineering have recently visited dealerships where a request has been made to replace the Steering Gear for an oil leak in the area of the pinion housing, casting, yoke plug or the gaiter adjacent to the pinion housing. Following investigation the source of the leak path was identified as being from the supply and return hose O-ring seals. See attached document for examples.</p> <p>Action: If an oil leak is identified from the area of the pinion housing, casting, yoke plug or gaiter ensure that the leak is not as a result of a damaged or leaking O-ring seal on the supply or return hoses.</p> <p>Carry out the following steps where a Steering Gear leak is suspected:</p> <ol style="list-style-type: none"> 1. Thoroughly clean the area of the pinion housing, casting, yoke plug, gaiter and pipe connections with a suitable

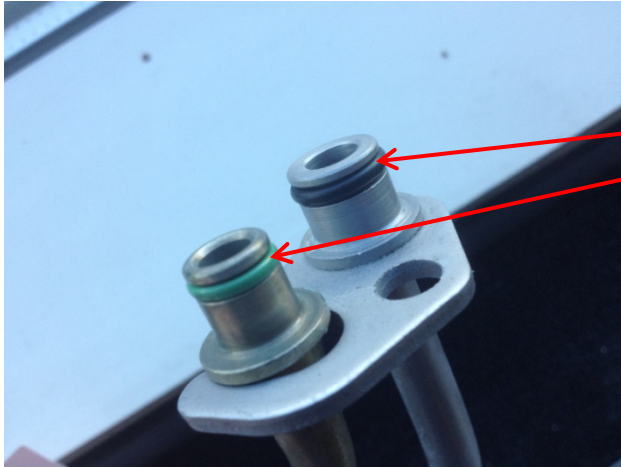
Picture of the O-ring and Pipe

O-rings available as service parts

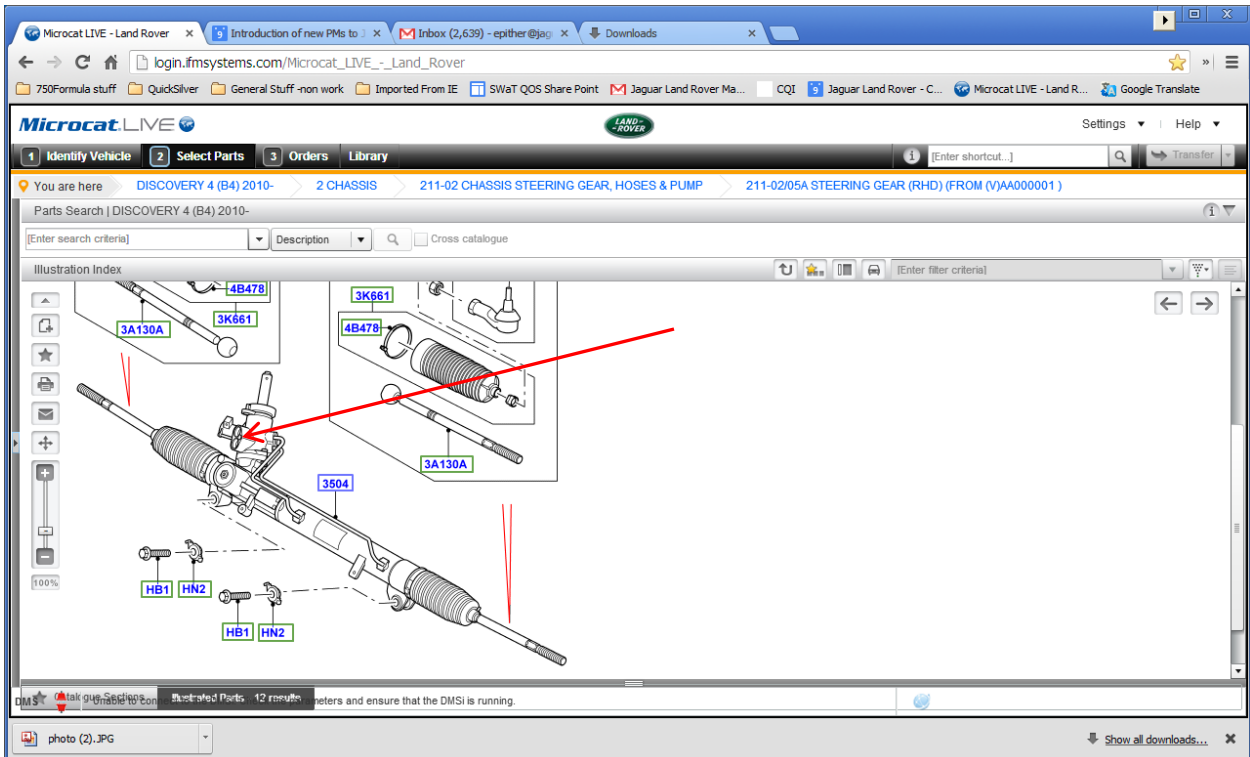
Location of the O-ring and Pipe

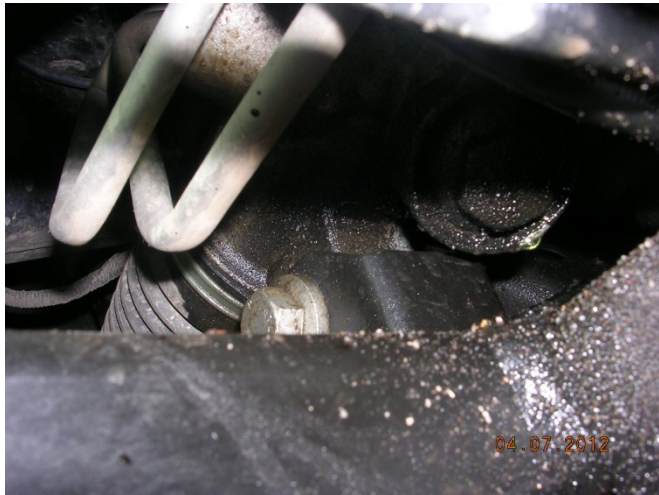
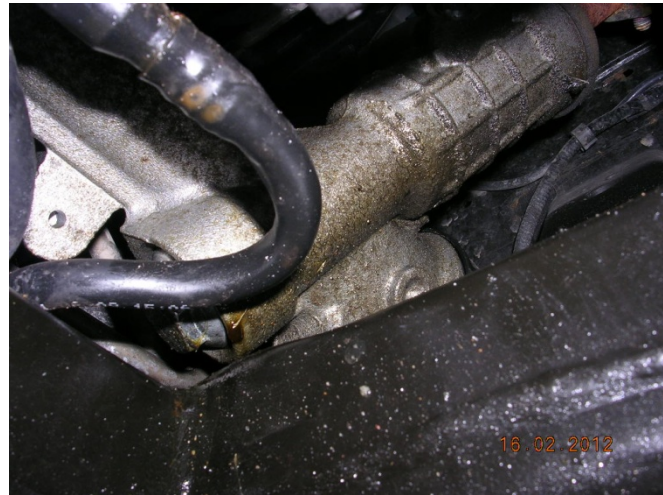
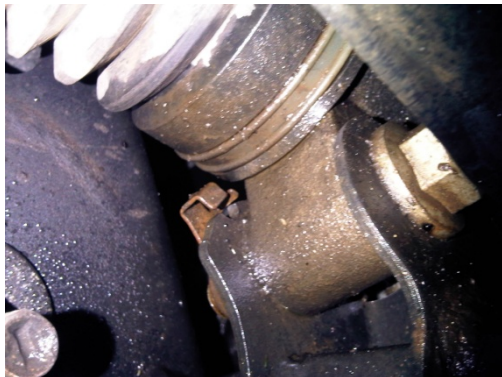
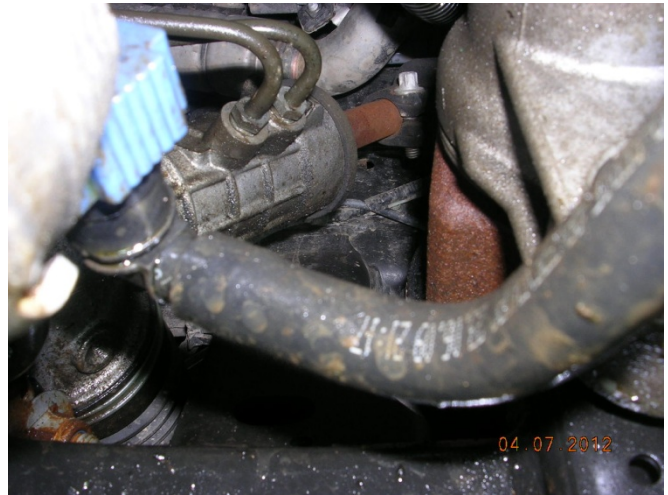
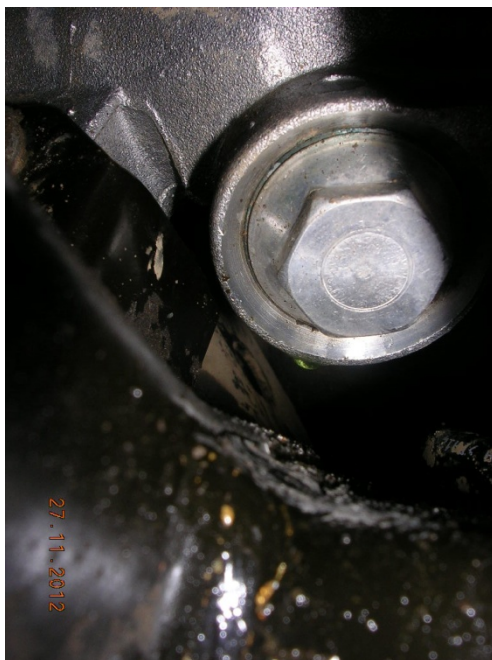
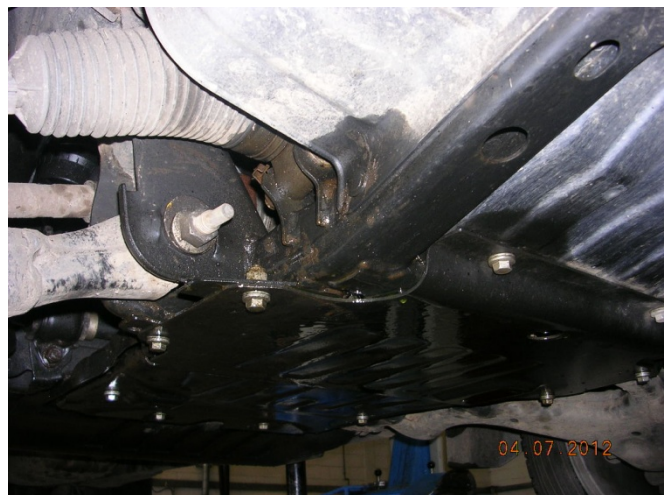
Examples of Leaks that maybe caused by this issue
