| Reference | SSM67617 |
| Models | LR2 / L359<br>Range Rover Evoque / L538 |
| Title | Haldex Coupling - Black substance/sludge observed in oil and pump housing |

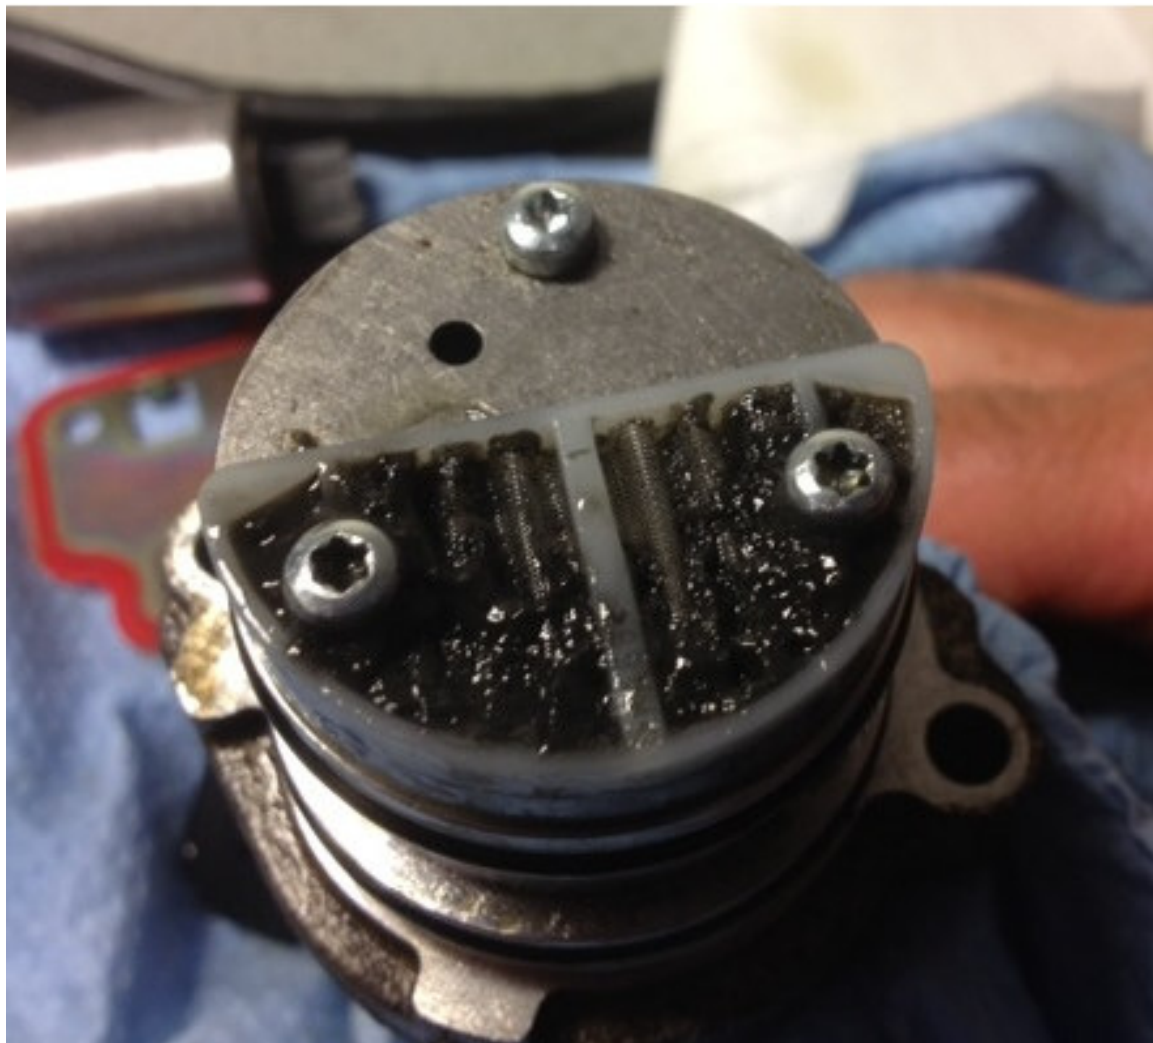
| Content | <p>Issue:</p> <p>During dealer technician investigation for related Haldex coupling issues and associated fault codes, technician's may identify a 'black sludge' type substance in the oil,filter,Haldex pump as shown in the picture attached.</p> <p>Cause:</p> <p>The 'black sludge' is from the additives in the oil solidifying out in the cold oil.</p> <p>Action:</p> <p>The 'black sludge' does not cause any Haldex functional issues, and becomes dissolved during normal operating temperatures.</p> <p>Dealer Technicians are advised to ignore the 'black sludge' type substance and not to replace related components due to this.</p> <p>For Haldex related concerns and associated DTC's, normal investigation and repair should be carried out according to the fault codes logged and recommended repair action carried out as detailed inTopix.</p> <p>Please take note to avoid unnecessary replacements of components for this concern.</p> |
