| Reference | SSM67737 |
| Models | Range Rover Sport / L494<br>Range Rover (All New) / L405 |
| Title | Earth fixings to Body Studs Potentially Loose (L405 & L494) |

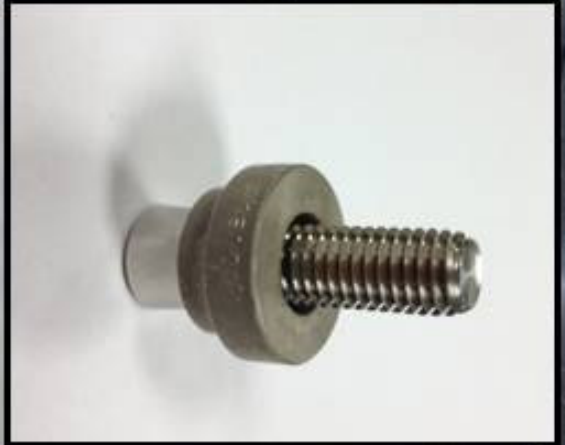
Anti rotation device

Welded stud

Repair stud
