WD10 - Replacing Analog Clock (Workshop Campaign)

Revision 1: September 17, 2013.
 This revision amends WD10 as follows:
 1. Originally published clock part numbers have been superseded with 000.043.209.09.001 OR 958.641.501.13 in the sections entitled "Parts Info" and "Invoicing".
 2. "Information" paragraphs have been added in the sections entitled "Parts Info" and "Attachment A" that deal with the handling/use of originally published part numbers 000.043.209.09 and 958.641.501.12.

Vehicle Type: **Cayenne (92A)/Cayenne Diesel (92A)/Cayenne S Hybrid (92A)
 Cayenne S (92A)/Cayenne GTS (92A)/Cayenne Turbo (92A)**

Concerns: **Analog clock on dashboard.**

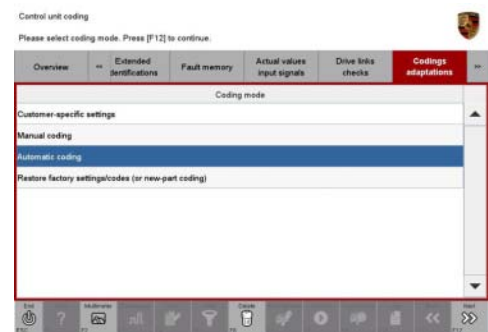
Automatic coding

- 2 Select ⇒ **'Additional clock instrument'** in the control unit selection screen (⇒ **'Overview'** menu) and confirm your selection by pressing **•>>“** .
- 3 When the question “Create Vehicle Analysis Log (VAL)?” appears, either press **•F12“** to create a VAL or press **•F11“** if you do not want to create a VAL.
- 4 Press **•>>“** to acknowledge the message informing you that campaigns for the vehicle are stored in the PIWIS information system.
- 5 Once the additional clock instrument has been found and is displayed in the overview, select the ⇒ **'Codings/adaptations'** menu.
- 6 Select the ⇒ **'Automatic coding'** function and press **•>>“** to start coding ⇒ *Automatic coding*.

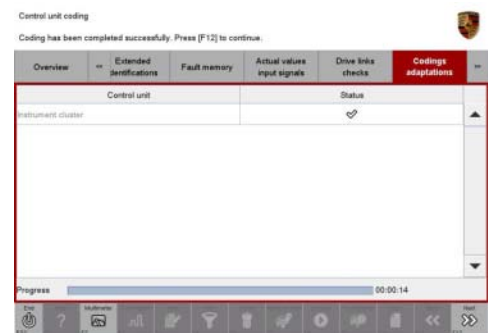
Coding successful

- 7 When coding is complete, the message “Coding has been completed successfully” is displayed and a tick appears in the 'Status' box ⇒ *Coding successful*.

If coding is not completed successfully (error message “Coding was not completed successfully”), coding must be **repeated**.
