MODEL
2011-2012MY
Optima (TF)

NUMBER
097 (REV 1, 11/08/2013)

TECHNICAL SERVICE BULLETIN

SUBJECT: FUEL FILLER DOOR INSPECTION AND UPGRADE PROCEDURE

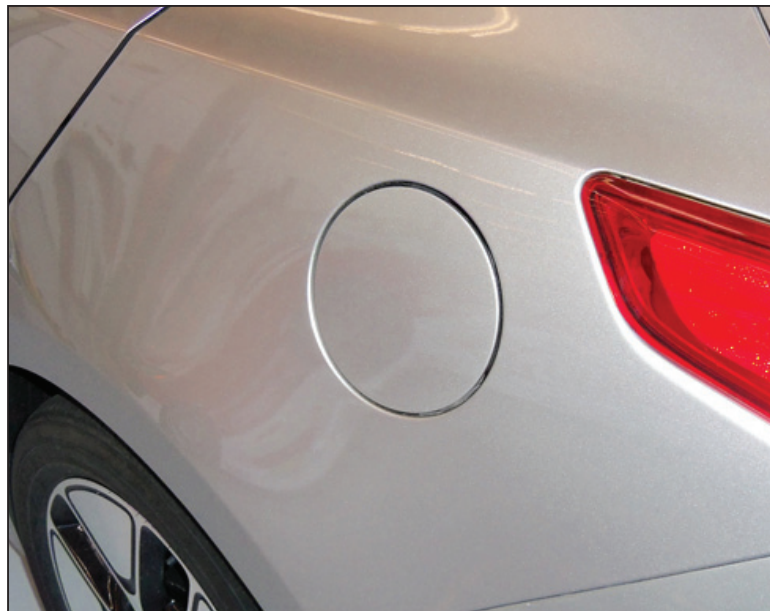
This bulletin provides the procedure for inspecting and repairing a potential concern with the fuel filler door operation on some Optima (TF) vehicles, produced from September 2010 to December 2011. The potential concern relates to decreased clearance between the fuel filler opener and the fuel filler door latch which may cause the fuel filler door to be difficult to open or close. Follow the procedures outlined in this bulletin to resolve the concern.

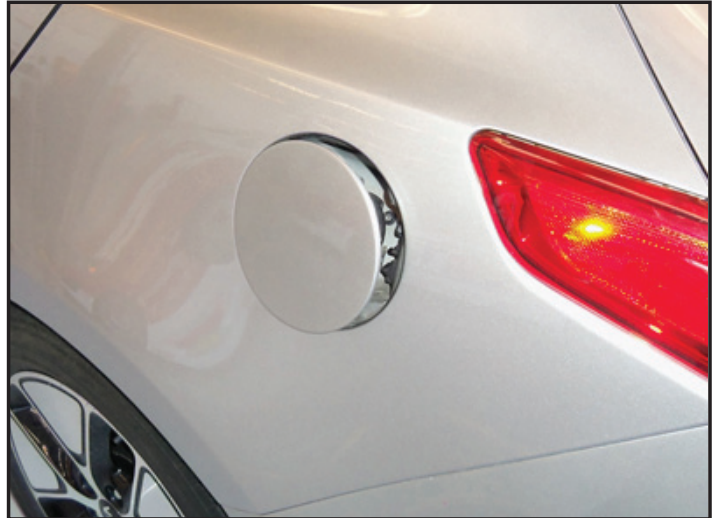
1. Open the fuel filler door and verify any clearance issues preventing the door from opening or closing correctly.
 - If the door operation is normal, no further steps will be necessary.
 - If there is evidence of abnormal operation due to clearance concerns, proceed to the Service Procedure below.

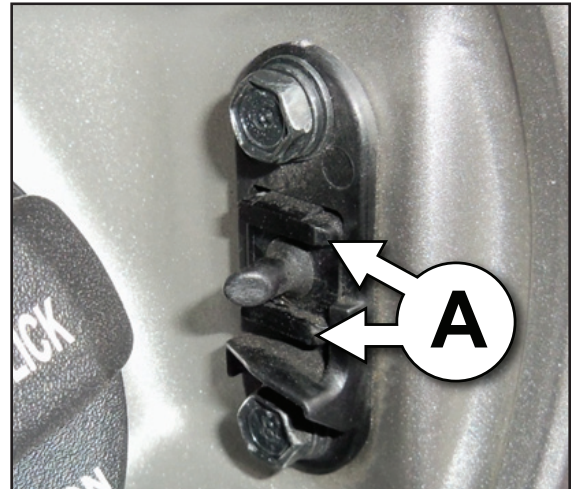
- 2. Note the location of the upper and lower alignment guides (A) protruding from the body of the fuel filler door latch.

These guides need to be filed down as noted below:
