MODEL
2011-2012MY
Sorento (XMa)

NUMBER
099 (REV 1, 11/08/2013)

TECHNICAL SERVICE BULLETIN

SUBJECT: SORENTO FUEL FILLER DOOR OPERATION UPGRADE

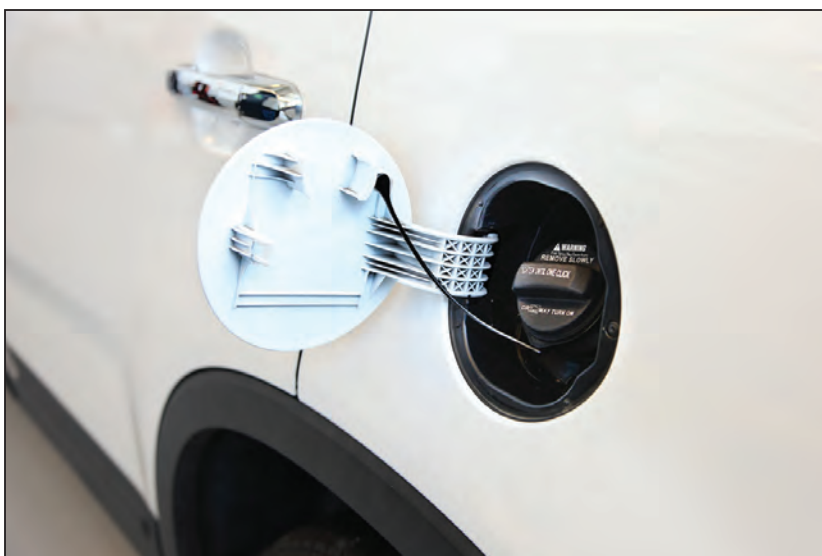
Fuel Filler Door

This bulletin provides information related to some Sorento (XMa) vehicles, produced from October 15, 2009 to September 29, 2011, which may exhibit a hard to open fuel filler door. Follow the procedure outlined in this bulletin to upgrade the operation of the fuel filler door.
