NUMBER
101 (REV 1, 11/08/2013)

MODEL
**2006-2014MY
Sedona (VQ)**

TECHNICAL SERVICE BULLETIN

SUBJECT: FRONT DOOR GLASS RUN CHANNEL REPLACEMENT

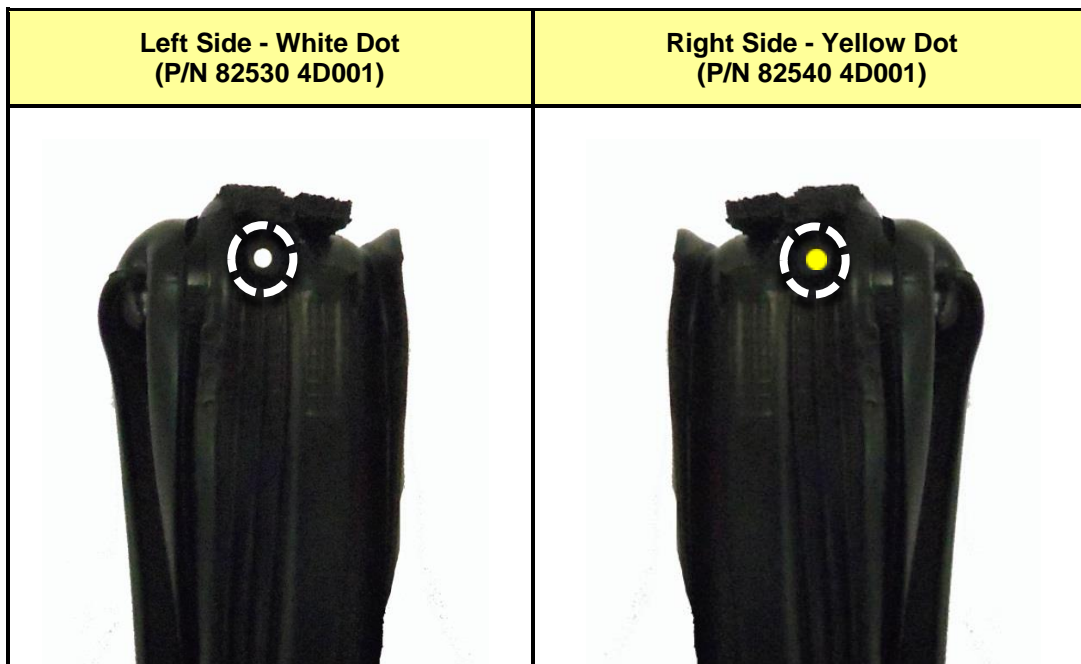
Refer to the table below to identify the right and left side glass run channels. Look for a Yellow or White dot painted on a projection on the underside of each glass run channel.
