REFERENCE:	Nova Bus Manuals
SECTION:	10 Transmission and control
RS N°:	MQR 7621-315
EFFECTIVE IN PROD.:	L702 (2012MA)

SUBJECT:	Ecolife transmission - Wiring harness for recording of turbine speed and output speed. ZF BULLETIN NO. 12_07.
JUSTIFICATION:	Due to wear at the plug connections of the wiring harnesses, sporadic contact discrepancies and entries in the error memory may occur.

No.12_07

Wiring Harness for Speed Recording of Turbine Speed (N_T) and Output Speed (N_Ab)

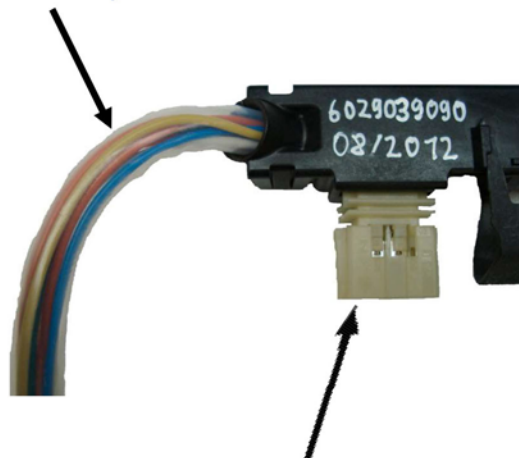
Due to wear at the plug connections of the wiring harnesses, sporadic contact discrepancies and also entries in the error memory may occur.

The new wiring harnesses are clearly visible due to different individual lines in terms of color.

Due to improved plug connections, higher forces for plugging the wiring harnesses in are necessary!

In case of error, the wiring harnesses must be exchanged according to the following table:

Designation	NEW	OLD
	Material number	Material number
Wiring harness internal, turbine speed (N_T)	6029.039.090	6029.039.048
Wiring harness internal, turbine speed (N_T) with oil level sensor	6029.039.106	6029.039.061
Wiring harness, output speed (N_AB)	6029.039.091	6029.039.049
