| RS N°: | MQR 7621-315 |

| SUBJECT: | Ecolife transmission with oil level sensor - Wiring harness for recording of turbine speed and output speed. ZF BULLETIN No. 12_07. |

No.12\_07

**Wiring Harness for Speed Recording of Turbine Speed (N\_T) and Output Speed (N\_Ab)**

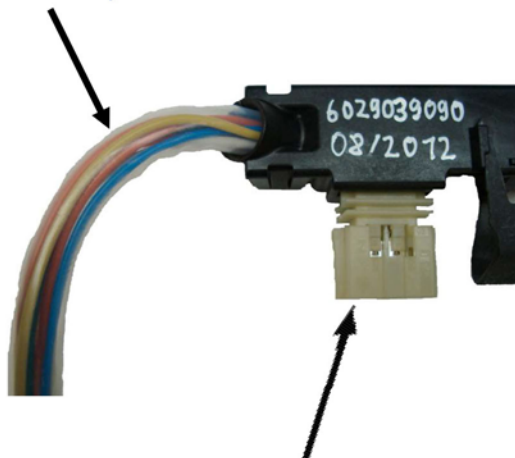
The new wiring harnesses are clearly visible due to different individual lines in terms of color.

Due to improved plug connections, higher forces for plugging the wiring harnesses in are necessary!
