| REFERENCE: | Nova Bus Manuals |
| SECTION: | 01 Stainless steel chassis |
| RS N°: | MQR 7621-091 |

| SUBJECT: | Repair structure in the rear wheelhouse area |

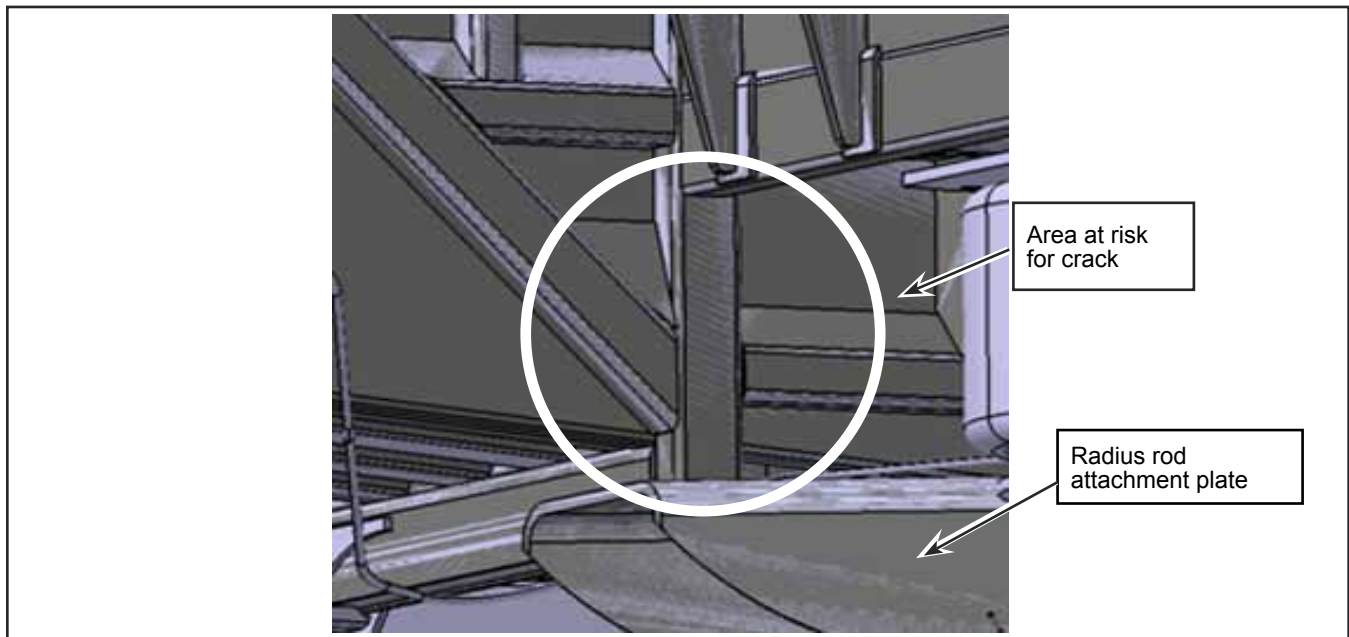
Figure 1 - Area at Risk of a Crack

| JUSTIFICATION: | The stainless steel structure of certain vehicles, with an offset engine, might have been subject to certain constraints which may cause cracking |

This information letter applies only to vehicles with a crack located near the radius rod attachment plate. See Figure 1 for the area at risk of a crack.
