**DART :02 Sensor**

**Property and Top Bus Number:** DART: 304500

**Issue:** 02 Sensor is falling on the turbo.

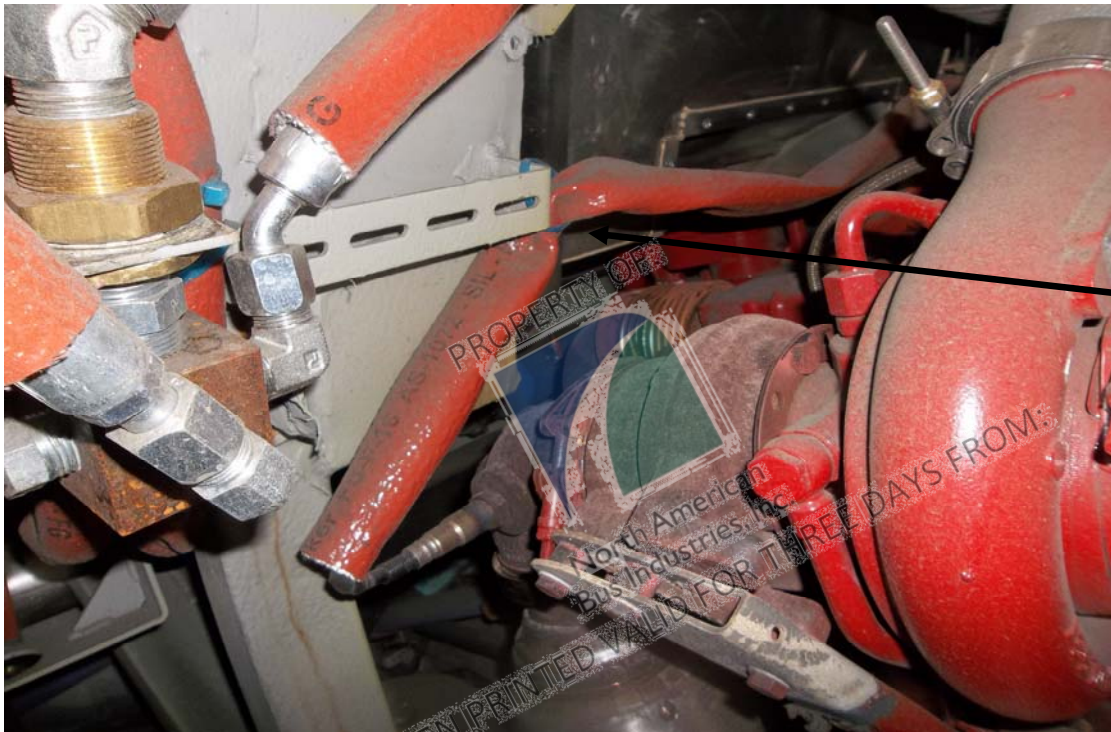
**Reason/ cause:** The sensor harness is being held up with a tie wrap and it is breaking.

Tie wrap to be removed

1. Park the bus and apply the parking brake.
2. Turn off main battery disconnect switch(es).
3. The 0/2 sensor harness is located above the turbo. Remove the tie wrap and install a clamp as shown below.

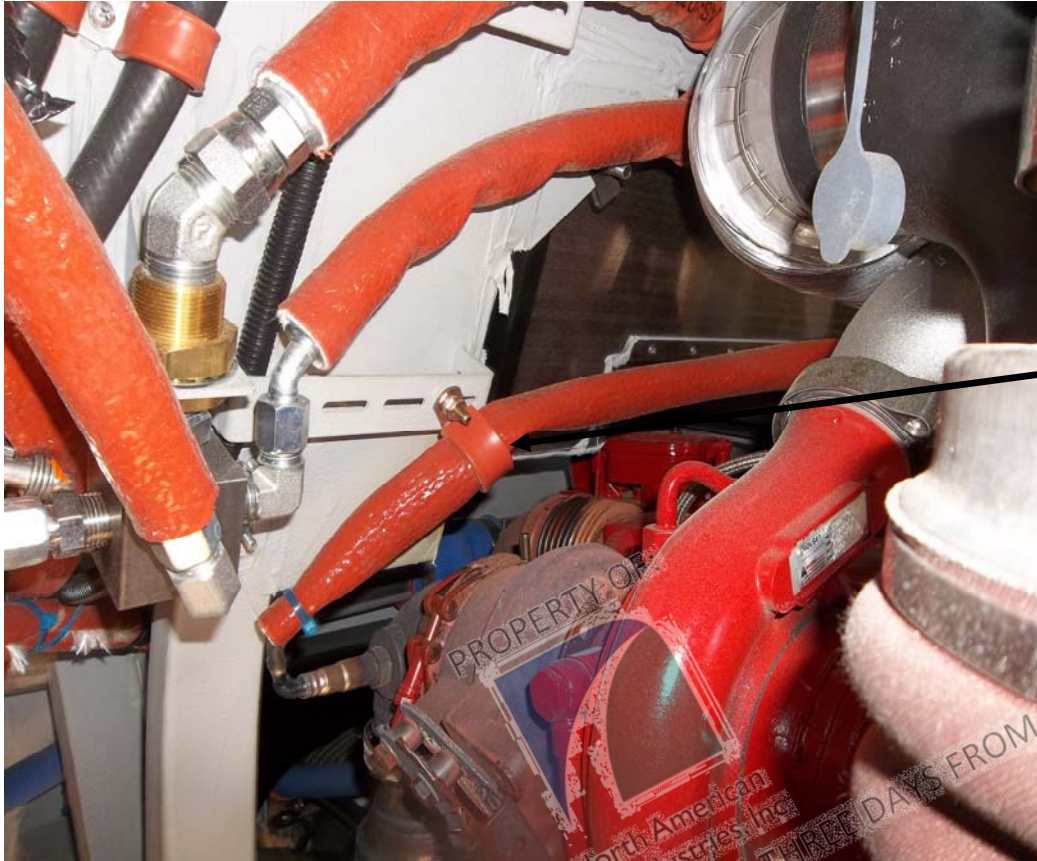
New clamp  
that was  
added

**Solution:** Replace the tie wrap with a clamp
