INSTRUCTION TO SERVICE

ITS: 5536	
SECTION:	219 Engine & Transmission
WRITTEN BY:	Mike Pearson
SUBJECT:	Replace exhaust flex connector.

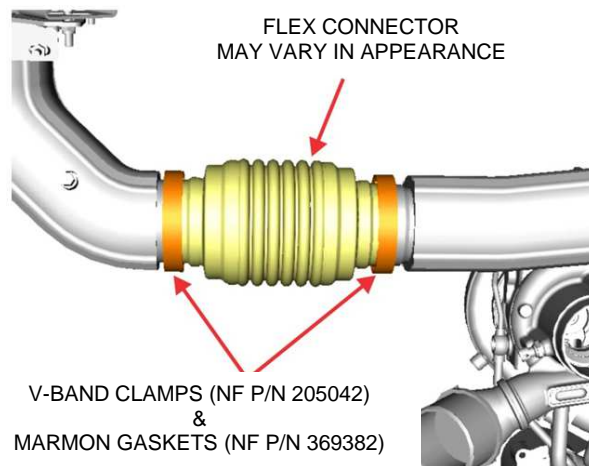
Figure 1: Exhaust Flex Connector

1. Turn the main battery disconnect switch to the “OFF” position.
2. Open the rear engine access door.
3. Locate the exhaust flex connector. See Figure 1.

4. Loosen V-band clamps P/N 205042 and remove the flex connector. Save the existing clamps and Marmon gaskets for reuse but discard the existing flex connector (exhaust bellows).
5. Collapse alignment tool P/N 6360381 and position in between the exhaust tubes.
6. Rotate both ends of the alignment tool until it locks into the expanded position (locating pin should be out of the slot and in contact with edge of the slotted end of the tool). Make sure that the flanged end of the exhaust tubes are properly seated to the tool. See Figure 2.

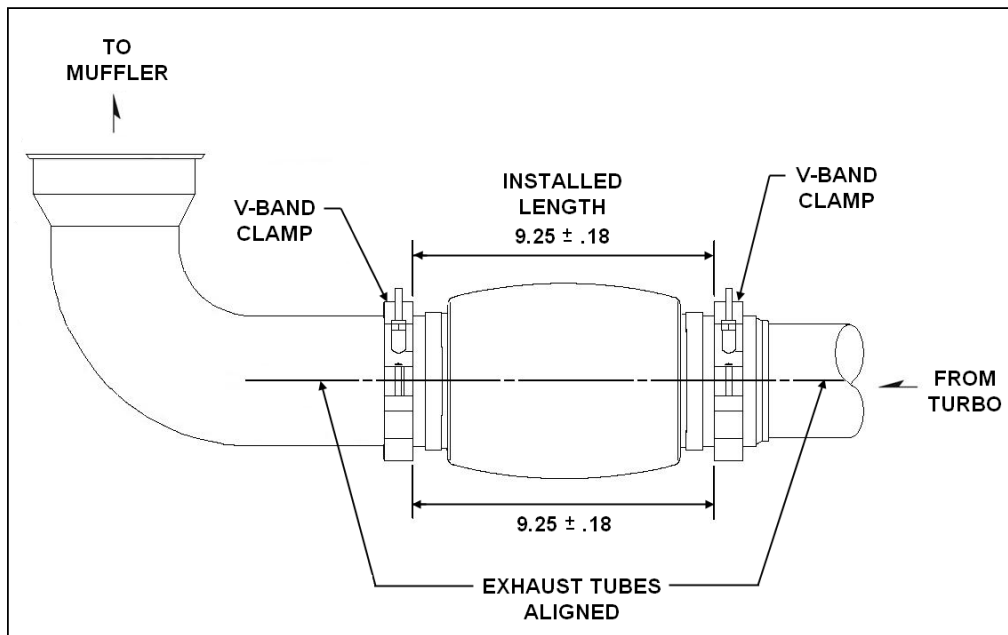
⚠ WARNING: The exhaust flex connector is extremely sensitive to installation. A slight misalignment will result in premature failure. Careful inspection of the alignment is necessary.

A correct installation will be straight. The exhaust flex connector will not be installed with torsion.

🔧 **NOTE:** Distance between torque clamp edges must be 9.25" +/- .18. Adjust exhaust tubes to achieve this distance (Free Length).

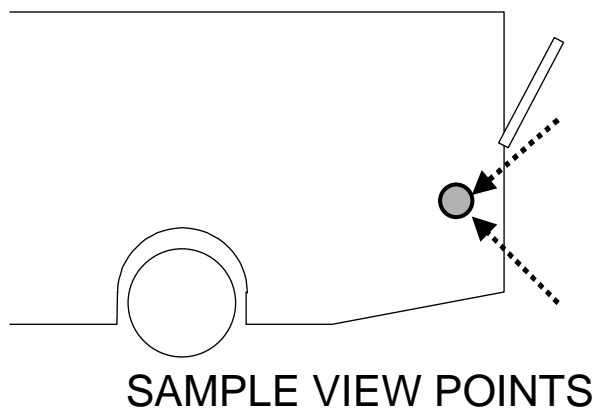
You must inspect the flex connector from two different viewpoints. ***If the bend or offset is in the same plane as your eyes, you will not see it.*** Be sure the two viewpoints are approximately 90° different, such as viewing from above, and below, as shown in the following diagram.
