INSTRUCTION TO SERVICE

ITS: 5591	
SECTION:	231 Cooling System
WRITTEN BY:	Michael Rooney
SUBJECT:	ISE Cooling Loop Bypass Removal

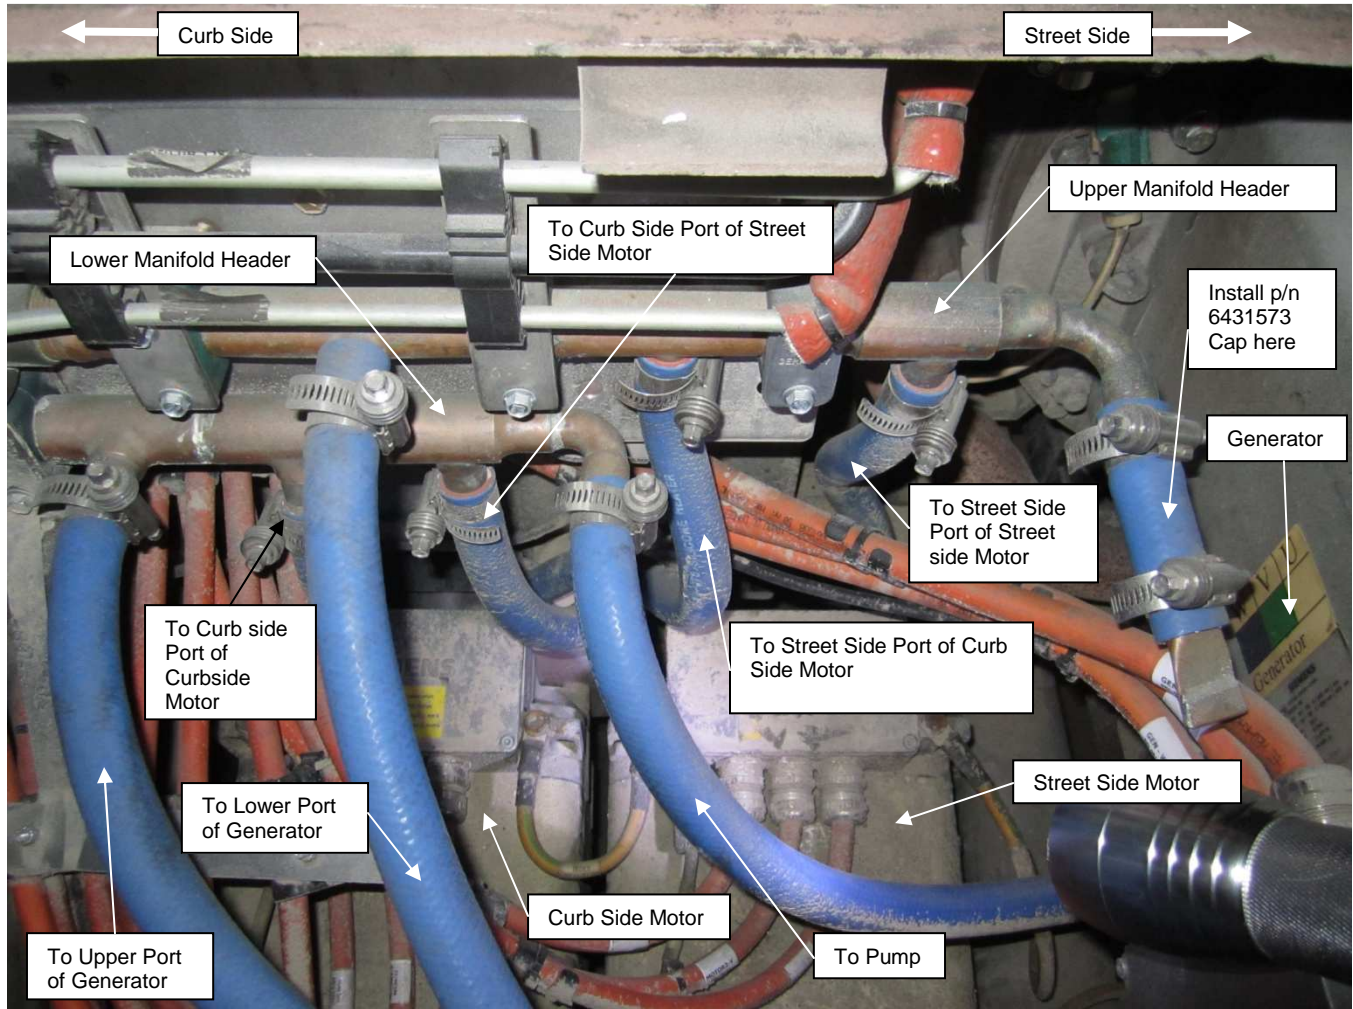
Figure 2: Hose Layout on Upper/Lower Manifold Headers

4. Locate the upper and lower coolant manifolds, generator and two electric drive motors. Figure 2.
5. Check to ensure that upper manifold header and components are plumbed as follows: Figure 2.
 - a. Street side branch of the upper manifold header should be closed off.
 - b. Second from street side branch of the upper manifold header should be plumbed to the street side port of the street side electric drive motor.
 - c. Curb side branch of the upper manifold heater should be plumbed to the lower port of the generator.
 - d. Second from curbside branch of the upper manifold header should be plumbed to the streetside port of the curbside electric drive motor.

6. Check to ensure that lower manifold header and components are plumbed as follows: Figure 2.
 - a. Street side branch of the lower manifold header should be plumbed to the coolant pump.
 - b. Second from street side branch of the lower manifold header should be plumbed to the curb side port of the street side electric drive motor.
 - c. Curb side branch of the lower manifold header should be plumbed to the upper port of the generator.
 - d. Second from curbside branch of the lower manifold header should be plumbed to the curb side port of the curbside electric drive motor.

NOTE: Most buses have a bypass hose connecting the upper and lower manifold headers as well as a Y-connection to the electric drive motors which will require modification.

7. If the hose layout at the upper and lower manifold headers does not match Figure 2 and or the bypass hose is present, the hoses will have to be reconfigured.

- a. Drain the coolant from the electronics cooling loop.
 - b. Change the hose connections as necessary to match the configuration shown in Figure 2. Use 3/4" hose NF P/N 106197 and hose clamps NF P/N 274935 as needed. Torque hose clamps to 56-62 IN-LBS.

- c. Refill the cooling system.
8. Locate the street side branch of the upper manifold. Figure 2.
 - a. Use a Rotary Tube Cutter to cut the end of the tube to remove the bead.

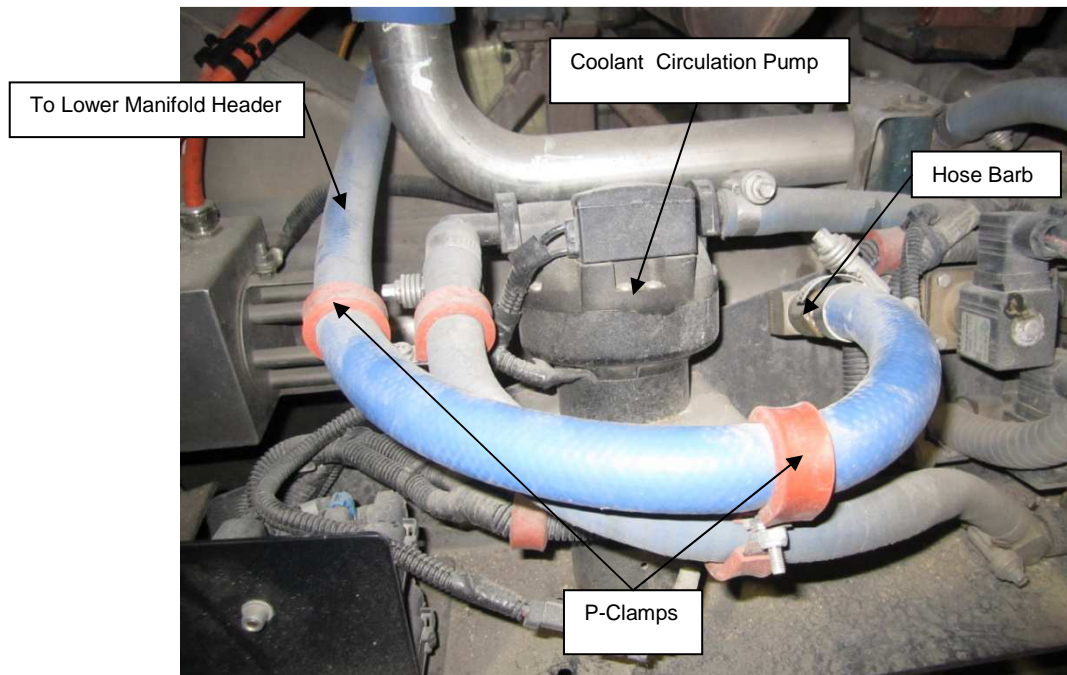
Figure 4: Hose Layout at Coolant Circulation Pump.

9. Open the curb side rear access door and locate the coolant circulation pump.
10. Check to make sure that the hoses are connected according to Figure 4.

11. Disconnect the hose that connects the manifold to the pump at the pump hose barb. Figure 4
12. Remove the P-clamps that locate the hose and remove the hose. Figure 4.
13. Remove the hose barb threaded into the pump and replace with the new hose barb NF P/N 218169.

NOTE: To prevent leaks it is necessary to use NPT thread sealant on the hose barb threads.

14. Install a new length of hose NF P/N 106197 from the pump hose barb to the coolant manifold and secure with new P-clamps NF P/N 247227 in the original locations. Figure 4.
15. Refill the cooling system and check for leaks.
16. Re-install the access covers.
17. Lower the rear chesterfield seats.
18. Turn the main battery disconnect switch to the "ON" position.
19. De-aerate the cooling system by topping off the electronics cooling system with fresh coolant while running pumps with master switch on. Continue to run pumps for ten minutes after full fill to de-aerate. Coolant level should be checked after the test drive and refilled as necessary.
20. Remove all tools and debris to return coach to service condition.
