DART Kneel Sensor Removal

Prepared by: John Gunter
Field Service Rep.

Property name and Top bus number: DART 304500 - 306500

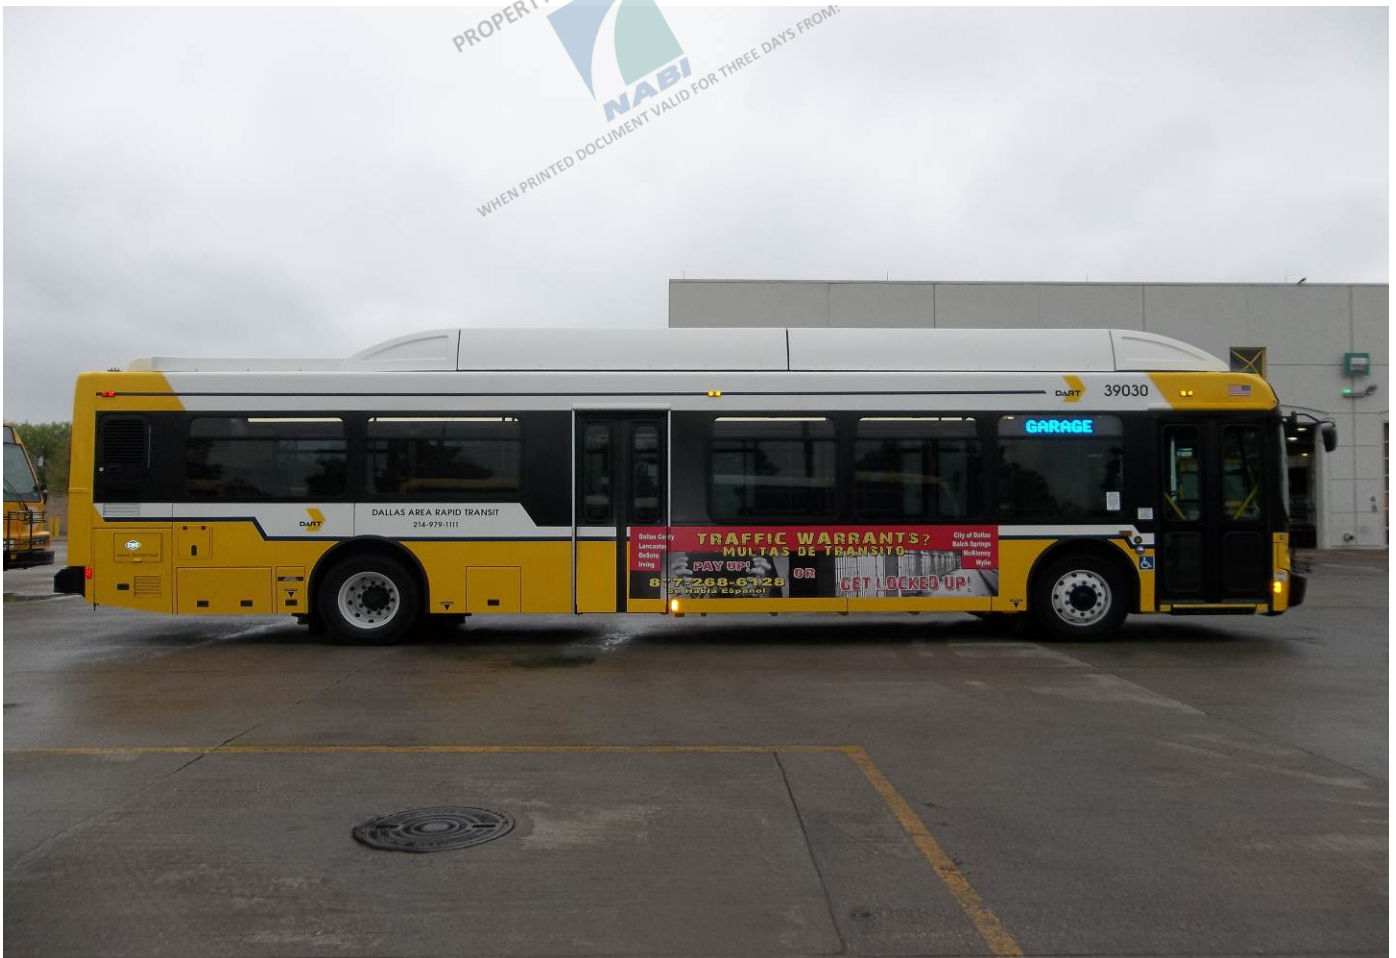
Issue: Kneel sensor is hitting the wheelchair ramp and getting bent.

Reason/ cause: Kneel sensor in hitting the ramp.

Solution: Remove the kneeling sensor and the bracket.

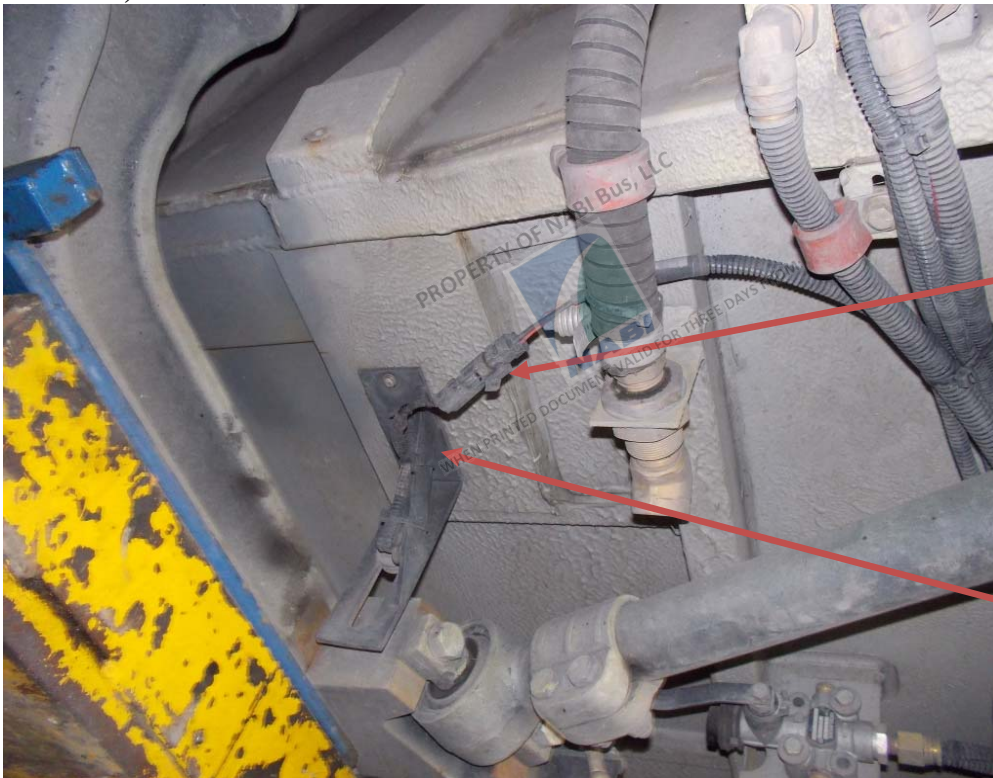
Connector to be removed and 2 pin dummy plug added

Two screws to be removed and bracket to be removed

1. Park the bus and apply the parking brake.
2. Turn off main battery disconnect switch(es)
3. Under the center of the bus at the leveling valve. Unplug the 2 pin weather pack connector going to the sensor and plug in the 2 pin connector with the dummy plugs installed. Remove the bracket that holds the sensor to the bus by removing the two screws.
4. Reprogram the bus with the MBC programmer using rev L and add the label the MBC with the rev. level date, and tec. initial.

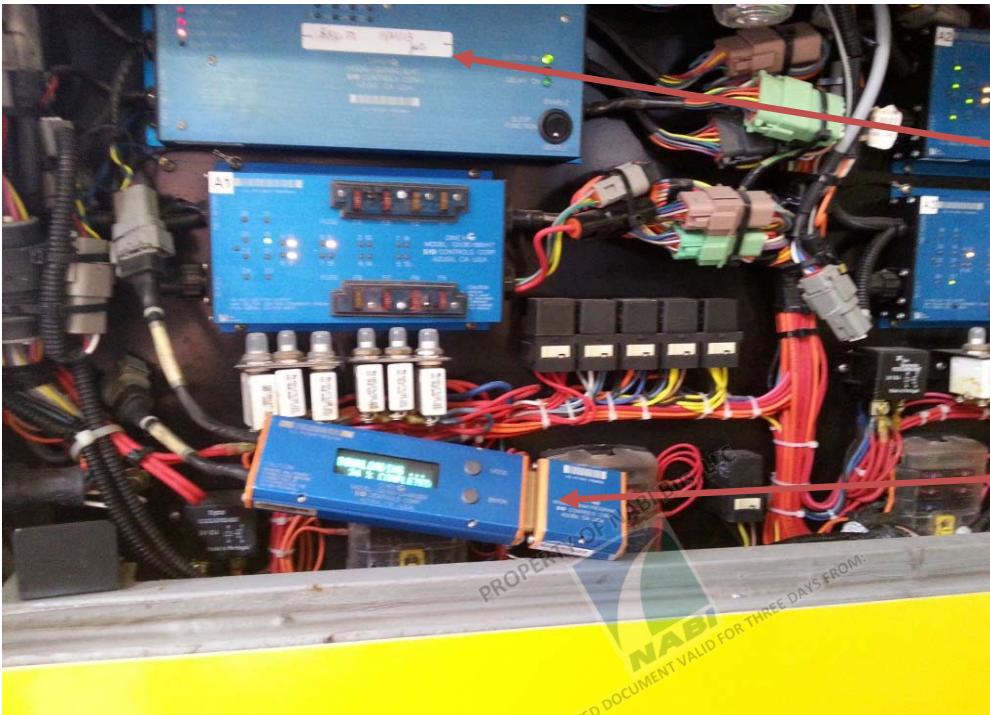
Label to be added

MBC programme
