INSTRUCTION TO SERVICE

ITS: 5322	
SECTION:	231 Cooling System
WRITTEN BY:	Michael Rooney
SUBJECT:	ISE Cooling Loop Bypass Removal

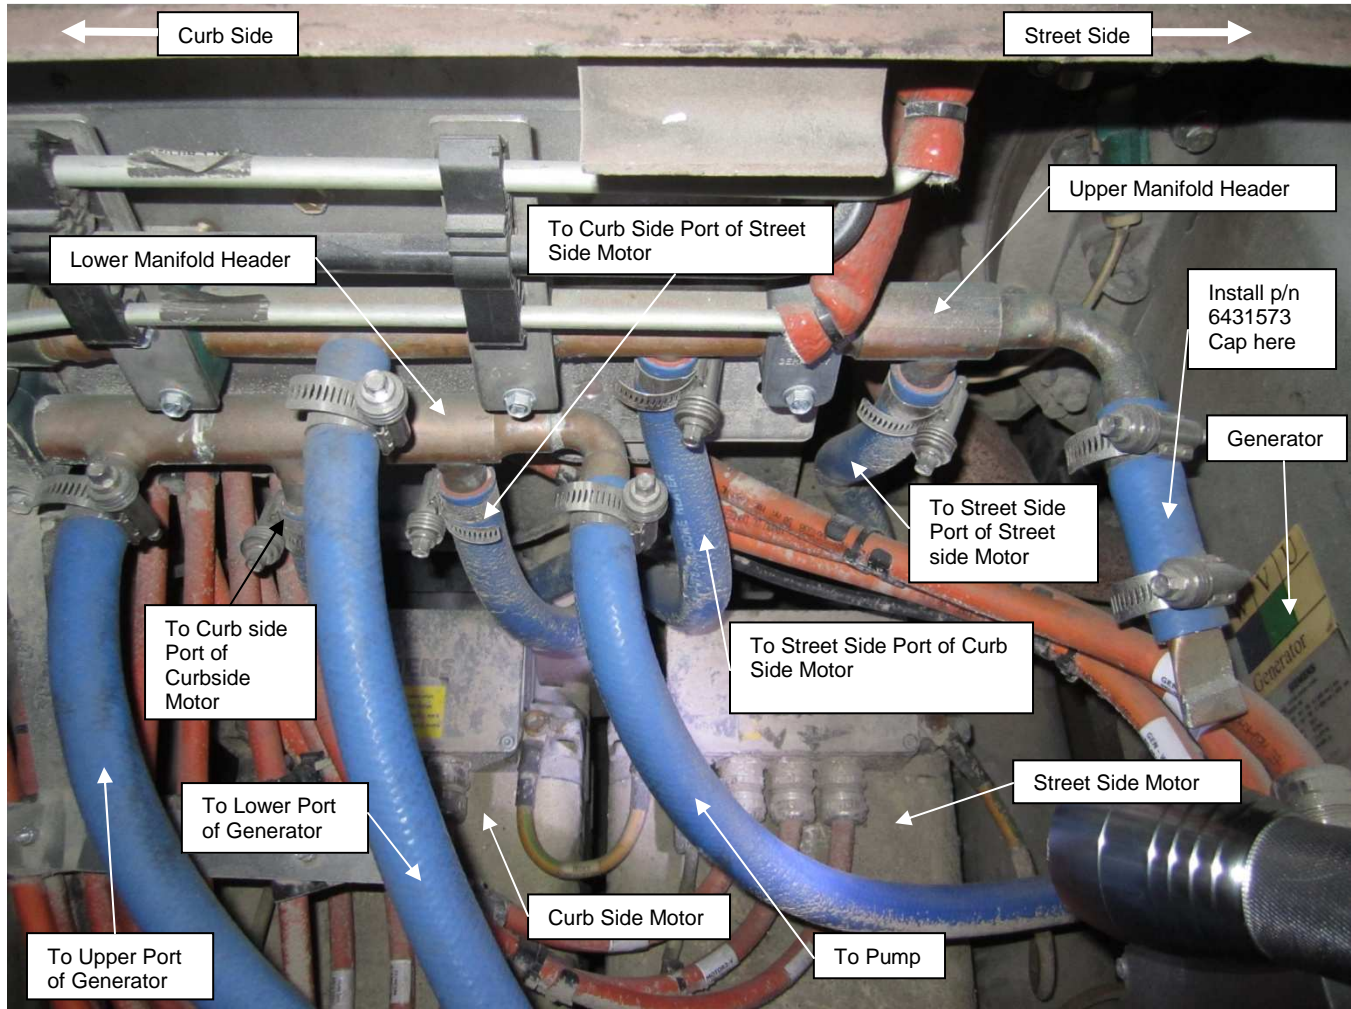
Figure 2: Hose Layout on Upper/Lower Manifold Headers

4. Locate the upper and lower coolant manifolds, generator and two electric drive motors. Figure 2.
5. Check to ensure that upper manifold header and components are plumbed as follows: Figure 2.
 - a. Street side branch of the upper manifold header should be closed off.
 - b. Second from street side branch of the upper manifold header should be plumbed to the street side port of the street side electric drive motor.
 - c. Curb side branch of the upper manifold heater should be plumbed to the lower port of the generator.
 - d. Second from curbside branch of the upper manifold header should be plumbed to the streetside port of the curbside electric drive motor.

6. Check to ensure that lower manifold header and components are plumbed as follows: Figure 2.
 - a. Street side branch of the lower manifold header should be plumbed to the coolant pump.
 - b. Second from street side branch of the lower manifold header should be plumbed to the curb side port of the street side electric drive motor.
 - c. Curb side branch of the lower manifold header should be plumbed to the upper port of the generator.
 - d. Second from curbside branch of the lower manifold header should be plumbed to the curb side port of the curbside electric drive motor.

NOTE: Most buses have a bypass hose connecting the upper and lower manifold headers as well as a Y-connection to the electric drive motors which will require modification.

9. If the hose layout at the upper and lower manifold headers does not match Figure 2 and or the bypass hose is present, the hoses will have to be reconfigured.

- a. Drain the coolant from the electronics cooling loop.
 - b. Change the hose connections as necessary to match the configuration shown in Figure 2. Use $\frac{3}{4}$ " hose NF P/N 106197 and hose clamps NF P/N 274935 as needed. Torque hose clamps to 56-62 IN-LBS.

- c. Refill the cooling system.
10. Locate the street side branch of the upper manifold. Figure 2.
 - a. Use a Rotary Tube Cutter to cut the end of the tube to remove the bead.

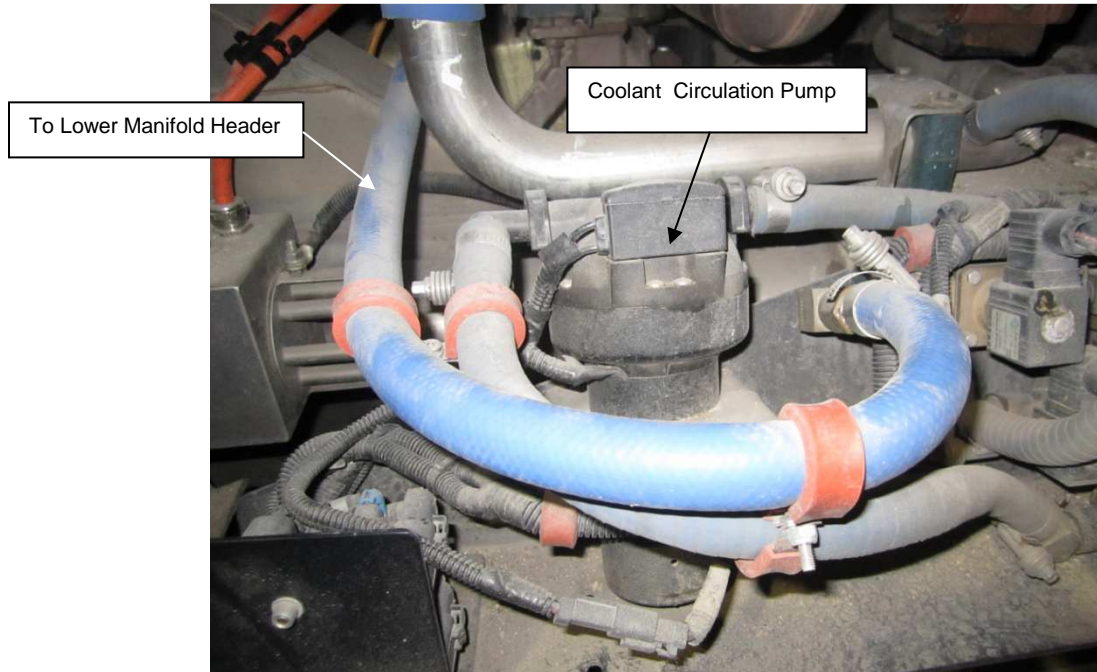
Figure 3: Hose Layout at Coolant Circulation Pump.

7. Open the curb side rear access door and locate the coolant circulation pump.
8. Check to make sure that the hoses are connected according to Figure 3.
