## INSTRUCTION TO SERVICE

**ITS: 5481**

| <b>SUBJECT:</b> | Rework OK6 Transmission Cooler Wire Harness UV Damage |

# ITS5481

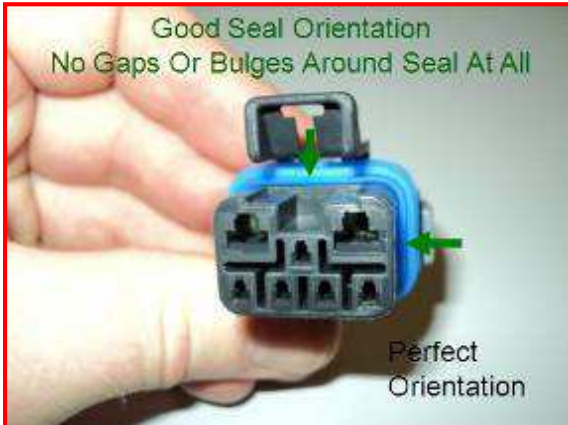
**Fig. 4a: Perfect Orientation**

NOTE: Inspect blue seal on the main harness to ensure it is oriented properly on the connector before installation and is not damaged. Rotate Seal as required. Applying a thin film of grease or lubricant to the seal will aid in the installation process (Figures 4a and 4b). If the seal is damaged or missing it will need to be replaced (EMP P/N EXP11110002 – or choose one from discarded harness).

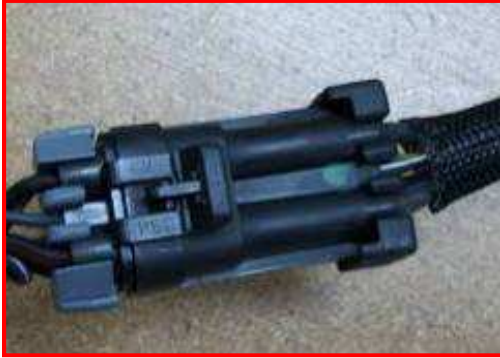
**Fig 6a: No Seal Visible, Correct**

NOTE: When connecting Main Harness to Fan Harness, the connector is seated when you will hear or feel a “click”. Make sure the seal is not visible. If there is blue seal visible after the connector is seated then the connection will not be sealed and be compromised (Figures 6a and 6b).

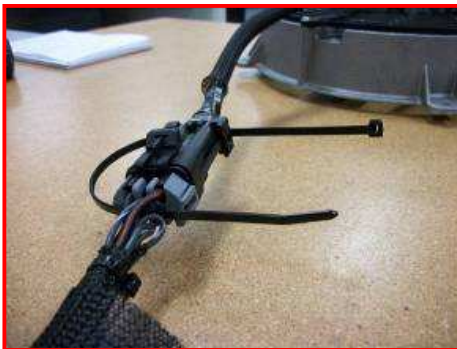
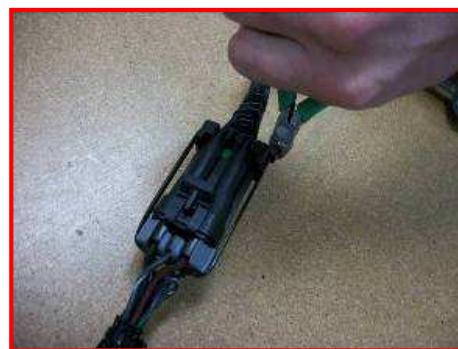
**Fig. 6a: Zip Tie Inserted**

**Fig. 6b: Zip Tie Secured and Trim**

- d. Connect fans 1, 2, 5 and 6 to their mating harness connector.
- e. Cap harness connector for absent fans (3 and 4) with supplied cap (EMP P/N 3250031023).
- f. Once each fan is connected properly, insert 11” zip tie (EMP P/N 3330036029) through the wire bundle on the fan side and then through the harness side. Tighten zip tie to secure connector and trim excess (Figures 6a and 6b).

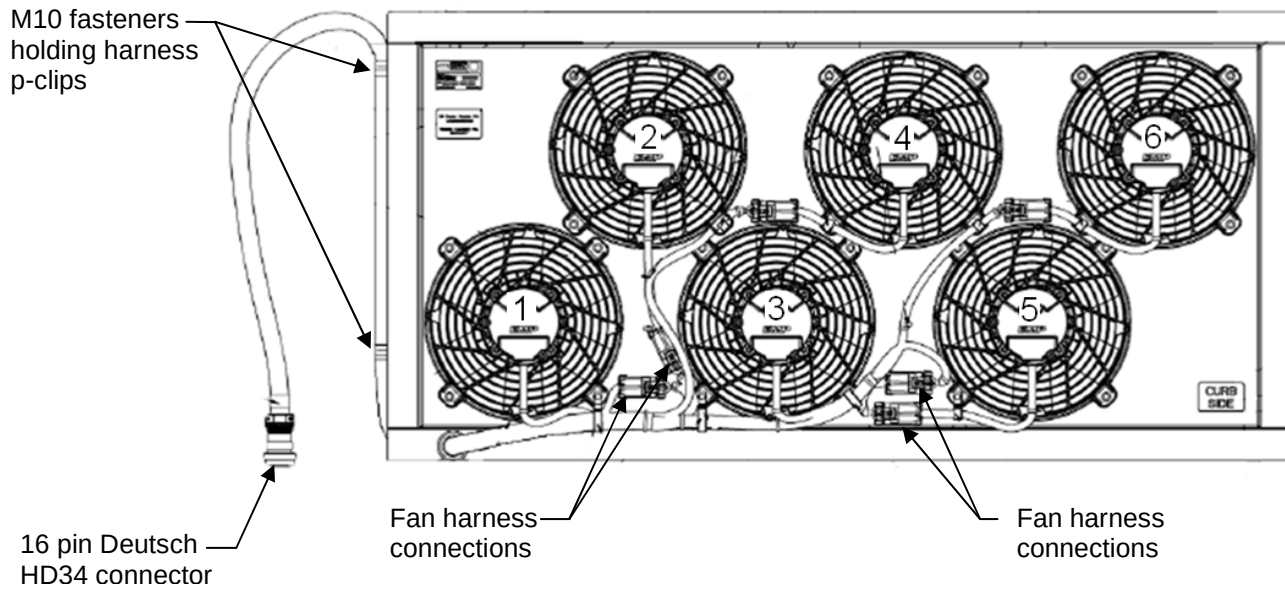
BEFORE:

Rooftop OK6 units are subjected to large amounts of UV radiation by the sun. Over time the red wires in the harness can become brittle and the wire insulation can crack, exposing the bare wire. Red wire UV damage is occurring on roof mounted OK6 Allison Hybrid Oil Cooler fan wire and harnesses installed in New Flyer buses prior to the spring of 2011. Continued UV exposure can cause copper wire to be exposed which if not repaired will lead to an inoperable fan. An inoperable fan will lead to possible fan fault dash light, hybrid propulsion overheat, initial system overheat dash light and in extreme cases propulsion system shut down due to overheat.
