Special Bulletin

SP13-326B

TITLE: STRUCTURAL REINFORCEMENT BI-FOLD DOOR AFT CYLINDER SUPPORT
Prevost vehicles

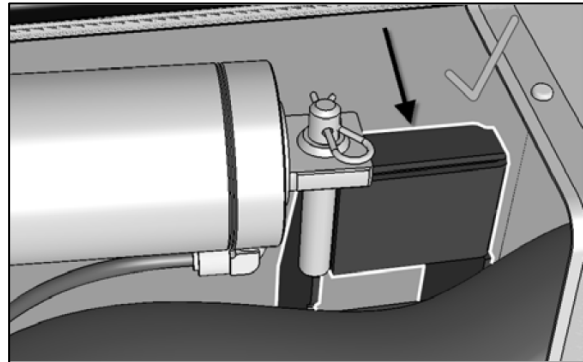
Figure 3

2. Inspect the aft cylinder anchor bracket and pin. Make sure the welds and bracket are structurally sound before undergoing any work. (Fig. 3)
Inform Prevost of any apparent defect.

3. Protect flexible ventilation duct, any piping or electrical cables/connectors in the area before undergoing any work.
4. Remove air to the door by turning the emergency release air valve.
5. Remove airline from cylinder.
6. Remove hitch pin (Fig. 3) and cylinder rod end cap screw (Fig. 4), remove pneumatic cylinder from support.
