# PREVOST

## WARRANTY BULLETIN

### WB13-55A

| SUBJECT : | WELD INSPECTION ON TRIPOD FAN SUPPORT | | |

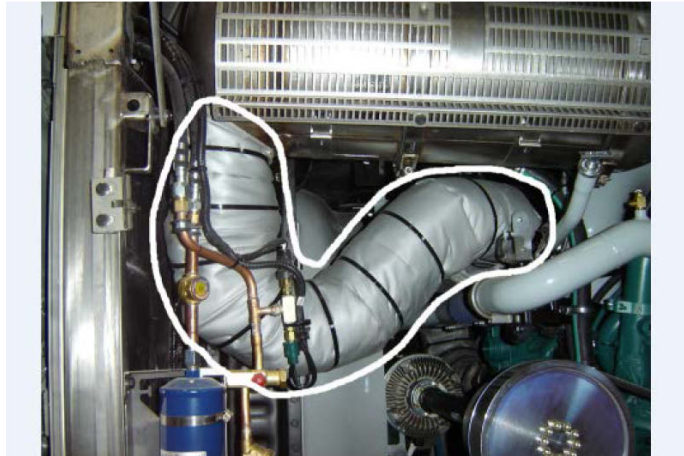
3. **H3 VIP MOTORHOMES.** The section of the exhaust pipe located between the DPF and the flexible section above the turbo must be removed to gain access to the tripod upper support.

- a. Clear the two (2) V-band clamps hidden under the insulating blanket at the junction with the DPF and at the junction with the exhaust flexible section.

- b. Undo the two (2) V-band clamps identified on the image.

- c. Unscrew the nut at the support bracket.

- d. Remove this section of exhaust pipe.
