PREVOST

WARRANTY BULLETIN

WB13-48A

DATE :	AUGUST 2013	SECTION :	07 - Transmission
EXPIRATION:	AUGUST 2015		
SUBJECT :	RETARDER COOLER PIPING SUPPORT - WELD INSPECTION AND REPLACEMENT

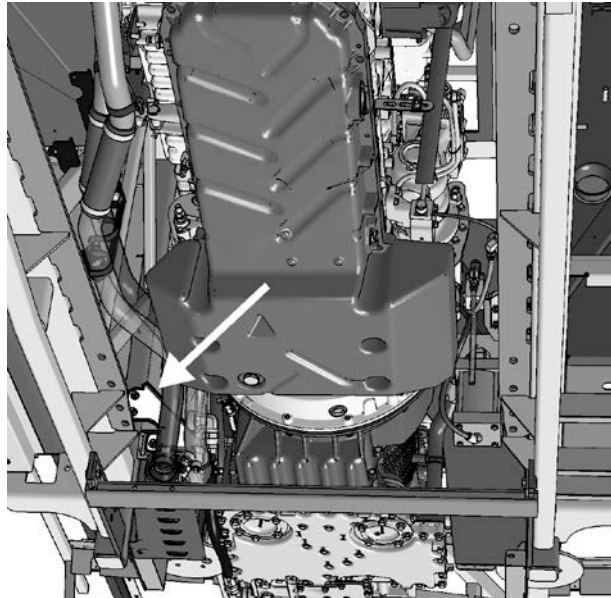
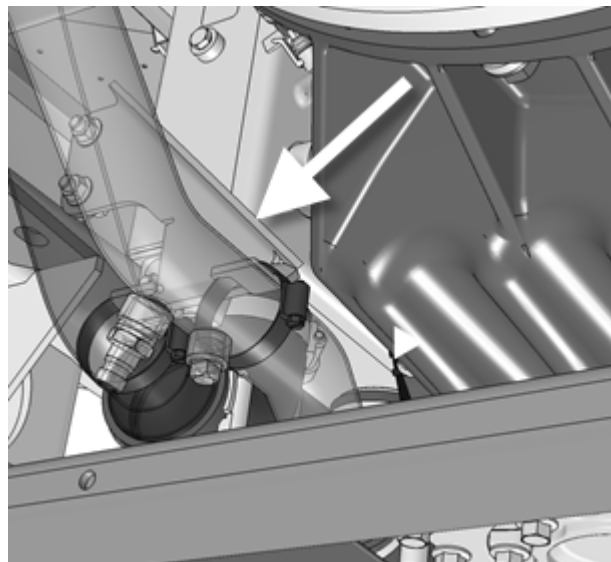
1. Lift the vehicle and locate the oil cooler pipe support. It is located left of the transmission

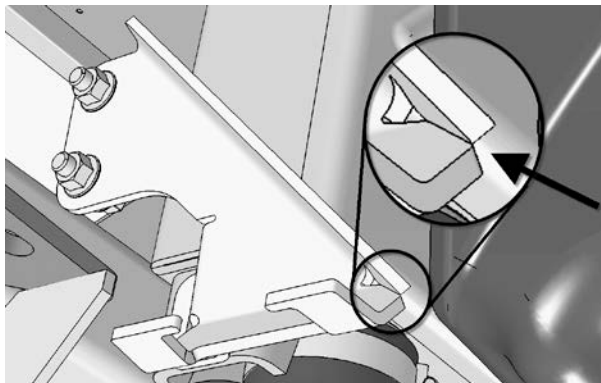
2. Using a telescopic inspection mirror, Make sure there is a weld fillet at this location on the piping support.

(Piping removed for clarity)

If there is a weld present, no further action is required.

If there is no weld, the part should be replaced.

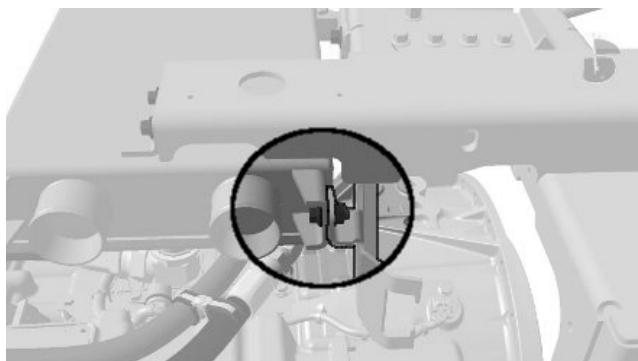
View from bottom

This should give you access to the support bolts.

1. Close the heating valves and make sure vehicle has cooled down for next steps.
2. Empty the coolant in an appropriate container.
3. Create some working space by removing the piping clamps, inlet and outlet piping and elbows. Collect any coolant left at this point.

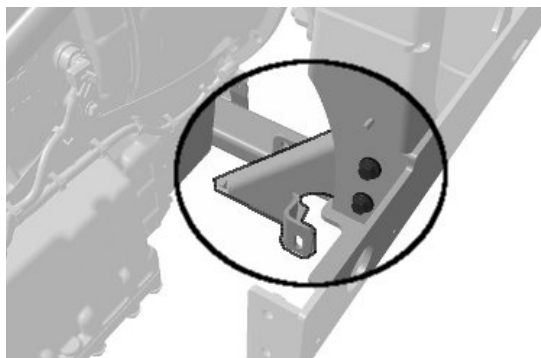
Refer to images for mounting bolt locations

Reverse angle.

4. Remove and discard the piping support and replace with the new part.
Tighten to 32 lbf-ft (44 N-m)
5. Re-install the piping and elbows.
6. Fill the coolant system.
7. Re-open heating valves.
8. Check cooling system for leaks and vehicle for proper operation.
