# PREVOST

## WARRANTY BULLETIN

**WB13-28**

DATE :	AUGUST 2013	SECTION : 18 - Body
EXPIRATION:	AUGUST 2015	
SUBJECT :	<b>REINFORCEMENT OF ENGINE COMPARTMENT DOOR PANTOGRAPH ARM</b>

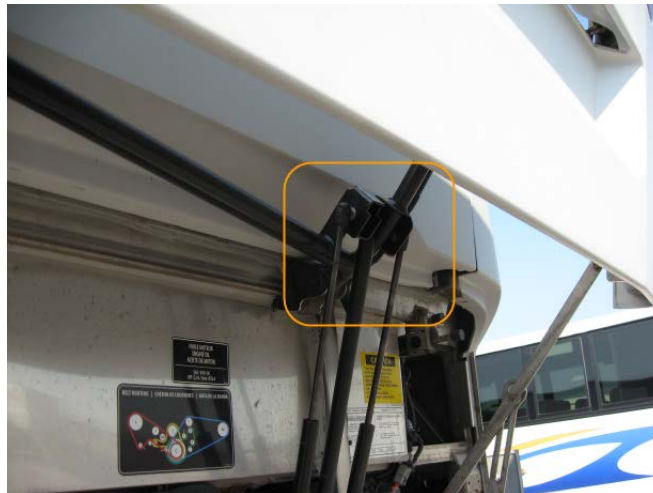
Fig. 1

1. Open the engine compartment door and locate the pantograph arm and the three (3) gas springs (right side of the vehicle).

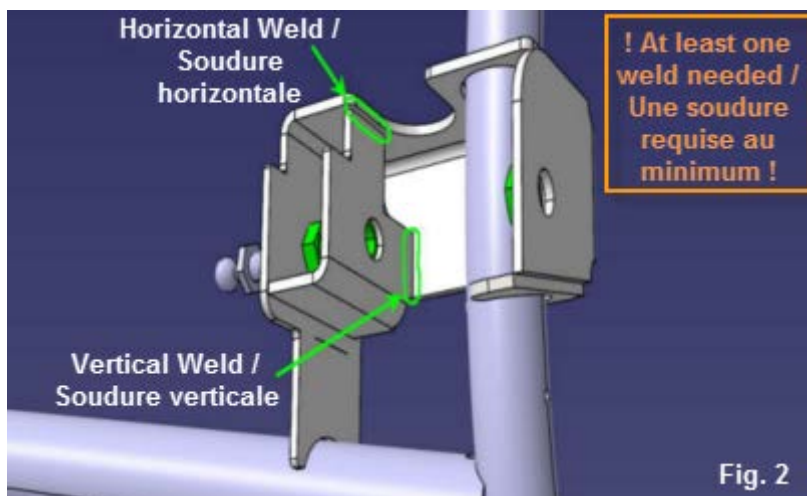
Fig. 2

2. The inside of the bracket must be welded *at least at one* of the two points shown on fig.2 (horizontal or vertical weld).

**NOTE: Some brackets may have been welded at both horizontal and vertical points.**

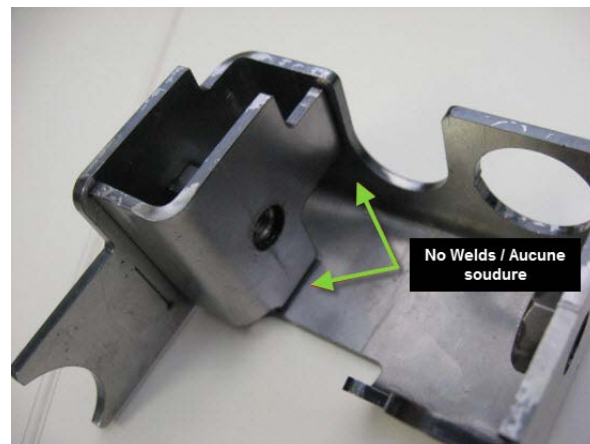
Fig.3

3. If the inspection reveals that *both* welds are missing, like shown in fig.3, a reinforcing block will have to be added to the bracket.

Furthermore, if both welds are missing from the brackets, inspection of the engine door gas springs is required.

The complete procedure and parts list to perform the reinforcing block installation and gas springs inspection is described below.

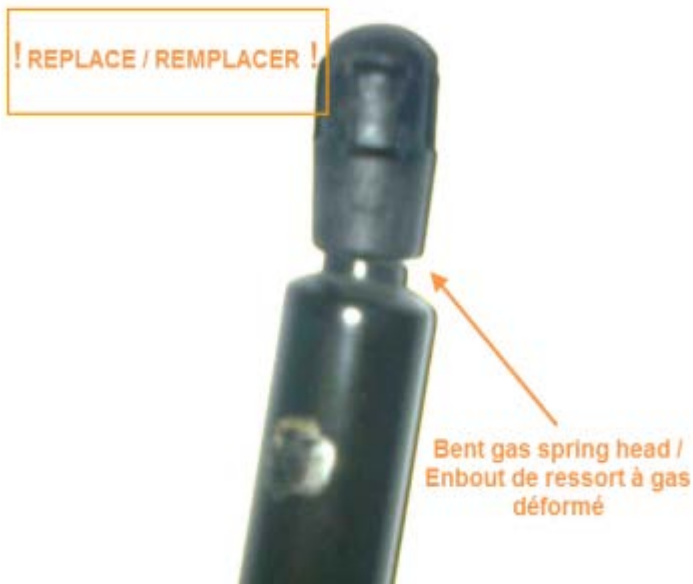
Fig.4

If both welds of the pantograph arm bracket are missing, the three (3) gas springs must be inspected to ensure that their mounting points (heads) are not bent or distorted.

Both heads on each gas springs must be parallel to the gas spring body.

If any gas spring head is bent (as shown in Fig.4), the gas spring must be replaced.

The engine compartment door is heavy and must be supported before any of the gas spring can be removed from the bracket.
