PREVOST

WARRANTY BULLETIN

WB13-62B

| SUBJECT : | TORQUE INSPECTION ON FRONT AXLE SUPPORT BOLT | | |

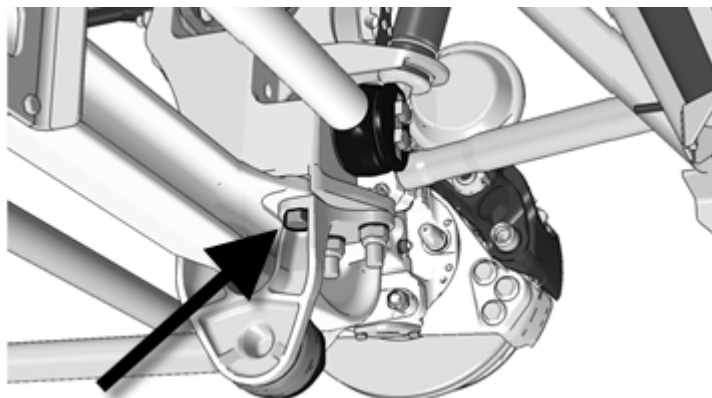
On the vehicles affected by this bulletin, torque must be verified on one of the axle support mounting bolts. An interference of a production tool with the casting on the nut side of the fastener may have resulted in lower effective torque.

1. On the front axle, left side (driver's side). Locate this bolt (arrow).

2. Verify the torque on this bolt.

Value should be

255 +/- 25 lbf-ft. (**230 - 280** lbf-ft).

If value is within range, clean and apply torque seal mark.
