## J-1939 CAN2 ENGINE SUBNET CABLE OVERLAY INSTALLATION

Prevost vehicles

| Model | VIN | | | | | | | | | | |
|---|---|---|---|---|---|---|---|---|---|---|--|
| NYCT X3-45 Commuter coaches<br>Model Year : 2012 |

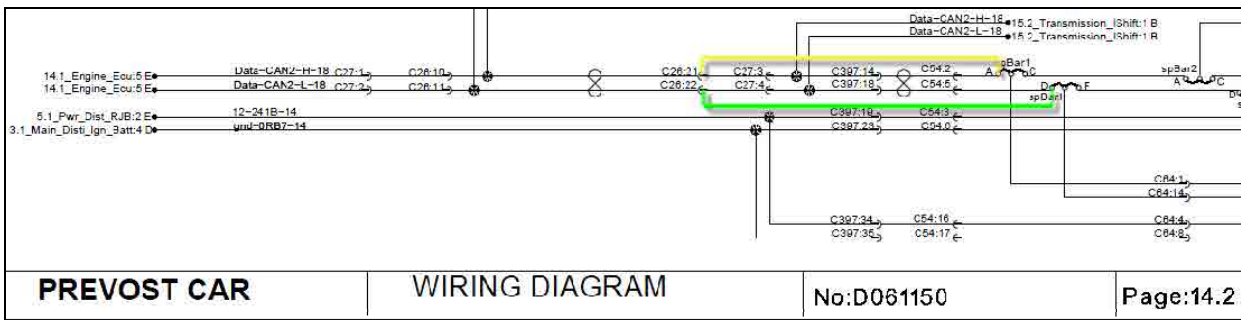
- To correct the J-1939 CAN2 and Nox sensor faults that have been intermittently logging, a dedicated CAN harness cable (twisted wires) will run from connector C26 near the ACM in the condenser compartment to the splice bar connector S-bar 1 at the rear of the bus (refer to the partial view of the wiring diagram below for a representation of the installation).

OVERVIEW- Can High=yellow wire, CAN Low=green wire

*We eliminate three connectors that were in the original harness and any associated resistance and voltage drops across the connectors.*

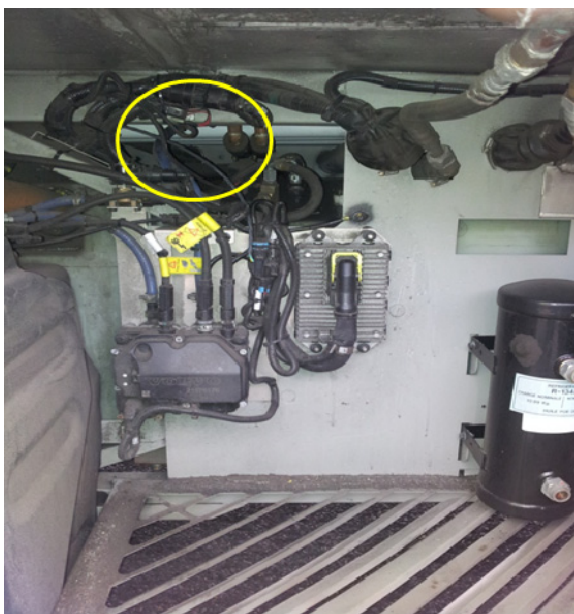
NEW HARNESS WILL START HERE AT C26, NEAR THE AFTERTREATMENT CONTROL MODULE (ACM)

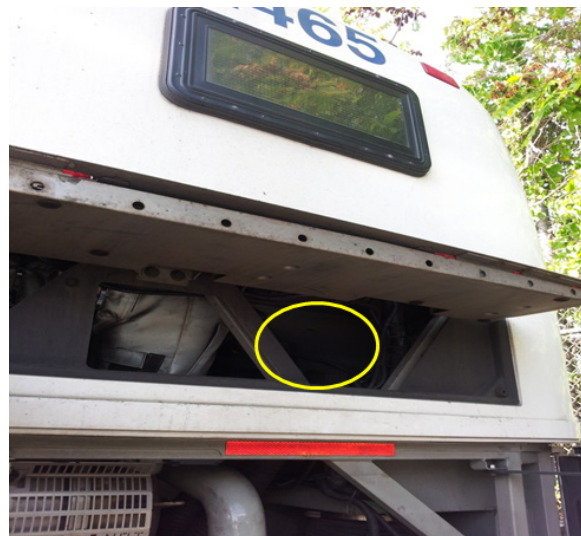
NEW HARNESS WILL END UP HERE AT S-BAR 1 SPLICE BAR CONNECTOR

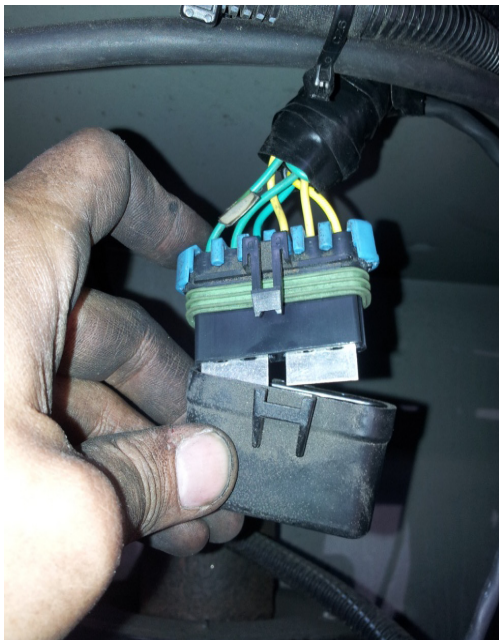
*Completed J1939 CAN 2 harness at rear of bus ready to secure to the after-treatment harness above.*

- 12) Reassemble S-bar 1 connector.
