Date	Expiration	Release	Page
11.2013	11.2014	01	1(3)

PCJ OIL PRESSURE SENSOR REPLACEMENT Prevost vehicles

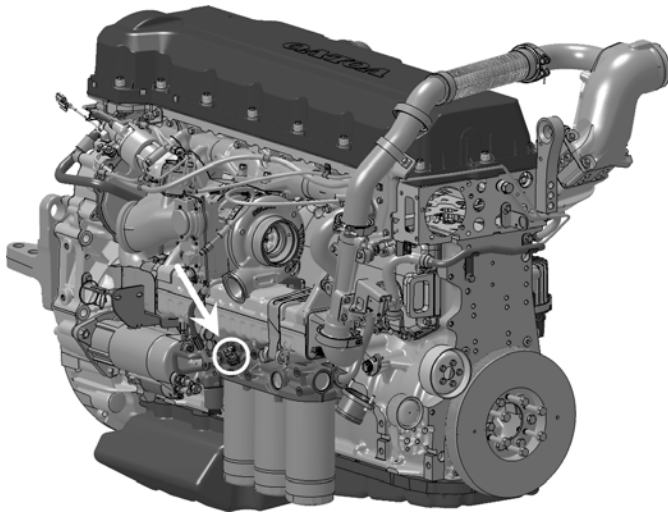
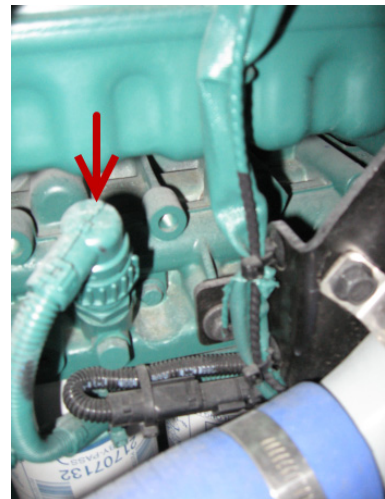
On the vehicles affected by this bulletin, the PCJ oil pressure sensor has to be replaced with an updated pressure sensor to avoid erroneous low oil pressure diagnostic codes.

- 1) Disconnect the PCJ sensor connector rotating the knurled collar counterclockwise. See the image below to locate the sensor.

- 2) Unscrew the sensor from the oil filter housing.
- 3) Clean out the electrical connector pins and sensor mounting surface with contact cleaner.
- 4) Install the new PCJ sensor (p/n 21634021). Torque: 18.5 ± 2 ft-lb.
- 5) Reinstall the connector and rotate clockwise to lock.
