Date	Expiration	Release	Page
11.2013	11.2014	1	1(3)

COOLANT FAN BELT REPLACEMENT WITH NEW SEVERE DUTY Prevost vehicles

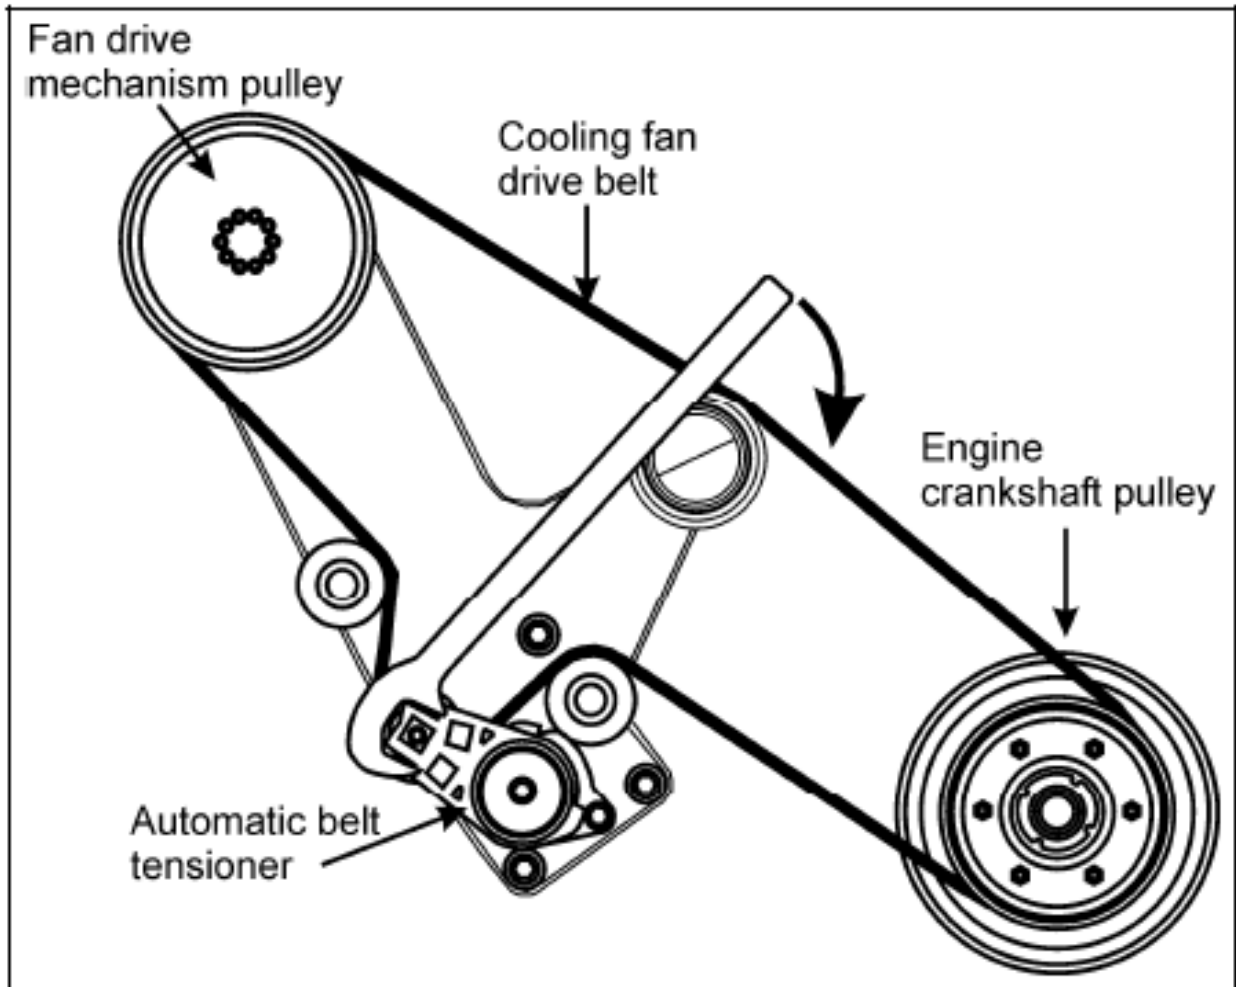
FIGURE 1: FAN BELT ROUTING (VOLVO D13 ENGINE)

On the vehicles affected by this bulletin, it is possible to experience sudden coolant fan belt snapping due to excessive force applied to the belt. Therefore, it is necessary to replace the current belt (**part # 5061284**) with a new Severe Duty belt (**part # 5060119**)

1. Using the special tool included with your vehicle (see inside the Warning Reflectors box located in the first curb-side baggage bay), rotate the automatic tensioner in clockwise direction to relieve tension on the belt and hold the tensioner in that position (Fig.1).
2. Remove the old belt from the pulleys.
3. Wrap the new drive belt around the fan drive mechanism pulley, the idlers and the automatic tensioner idler as shown on figure 1.
4. Release the tensioner slowly and let it return to its natural position, no further adjustment is required.
