PREVOST

WARRANTY BULLETIN

WB13-91A

DATE :	NOVEMBER 2013	SECTION :	23 - Accessories
EXPIRATION:	NOVEMBER 2015		
SUBJECT :	WIPER MOTOR REPLACEMENT

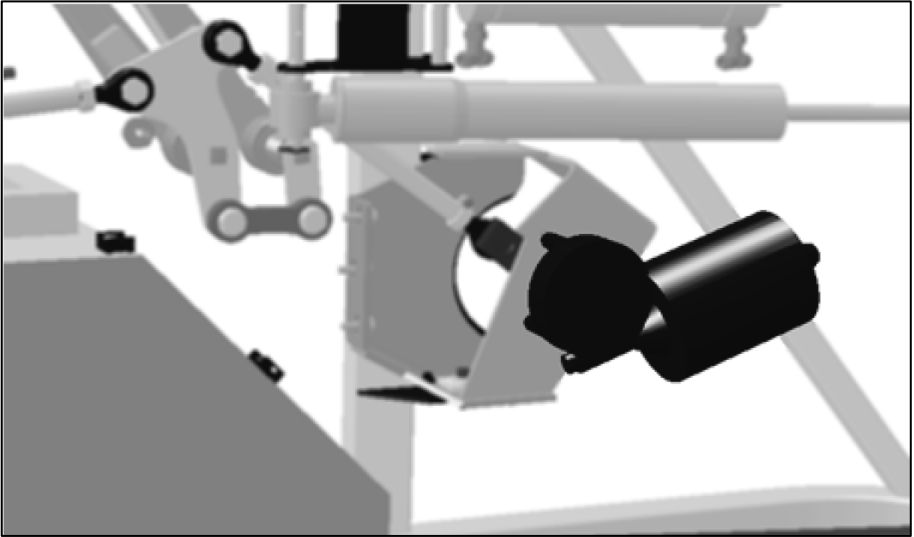
3. The wiper motor is located under the entrance door cylinder and damper.
