Revision C: This document supersedes previous revisions.  
Step 4 on page 3 updated as per comments "Remove and discard..." added.

## DPF SUPPORT BRACKET P/N 040837 CRACKING ISSUE

Prevost vehicles

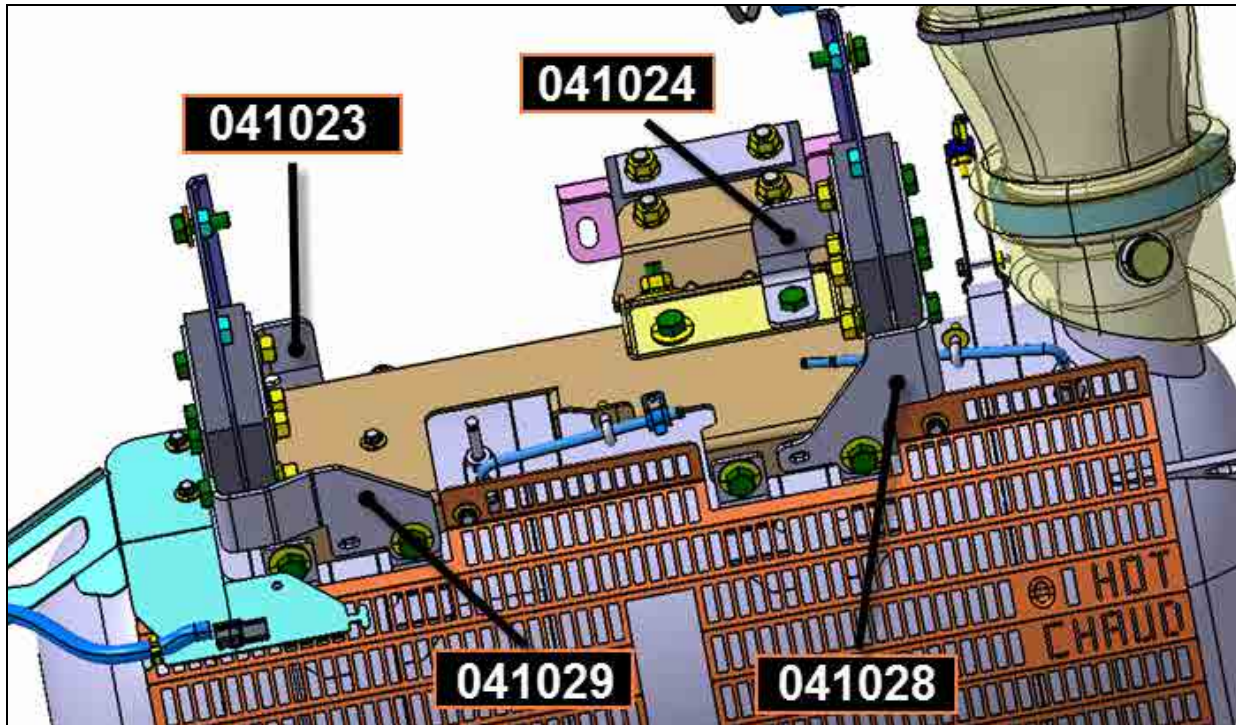
FIGURE 1: OVERVIEW OF FINAL INSTALLATION

On the vehicles affected by this bulletin, four (4) reinforcement brackets must be added to the DPF support.

1. First, take note that it is very important to install the reinforcement bracket one at a time in order to preserve the present DPF position adjustment.
2. **Torque seal (#685353 or similar) should be applied** once bolts are properly tightened.

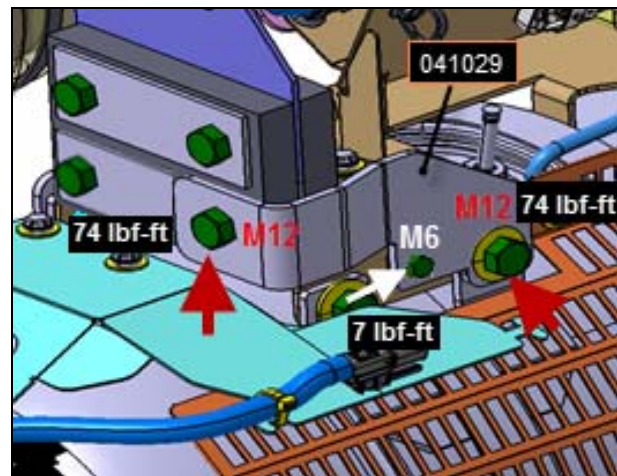
FIGURE 2

## BRACKET 041029

3. The rectangular stainless steel plate shall not be moved and must remain in place, between the rubber pieces and the reinforcement brackets. Having distorted SS plates is normal.
4. Unscrew and remove the three identified bolts in fig.2. Remove and discard the existing bracket.
- 2 x M12 bolts (see red arrow)
- 1 x M6 bolt (see white arrow)
5. Install new reinforcement bracket 041029 (shown in proper location, fig.2), secure using existing M12 bolts (red arrows) and M6 bolt (white arrow) (fig.2).

*Torque: M12 bolt (2x): 74 lbf-ft.*

*M6 bolt (1x): 7 lbf-ft.*

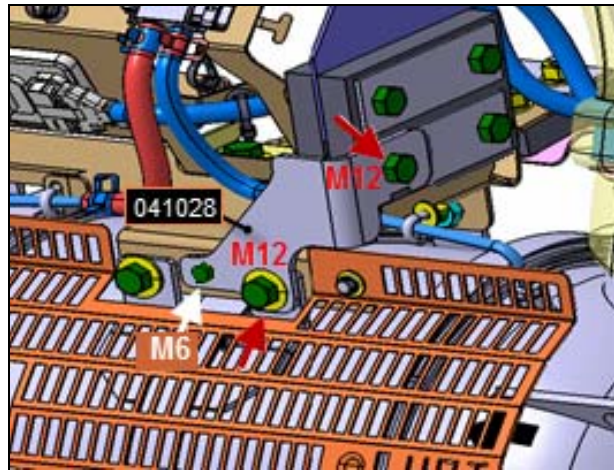
FIGURE 3

## BRACKET 041028

6. Repeat previous steps for the installation of bracket 041028 (figure 3) this time.

Torque: M12 bolt (2x): 74 lbf-ft.

M6 bolt (1x): 7 lbf-ft.

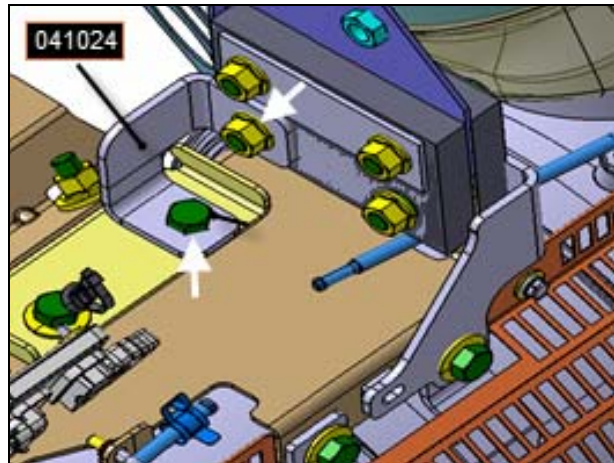
FIGURE 4

## BRACKET 041024

7. Install bracket 041024 similarly (figure 4). There is no M6 screw securing this bracket.

Torque: M12 bolt (2x): 74 lbf-ft.

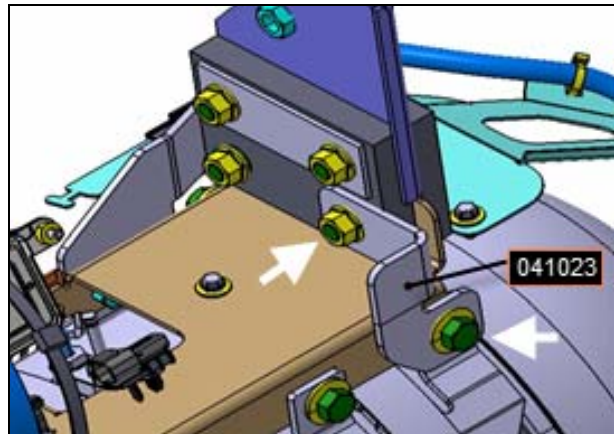
FIGURE 5

## BRACKET 041023

8. Install bracket 041023 similarly (figure 5). There is no M6 screw securing this bracket.

Torque: M12 bolt (2x): 74 lbf-ft.
