Subject: INFORMATION DISPLAY SHOWS "FOW INSPECTION REQUIRED" AND DTC C1A67:78 IS STORED	Bulletin No: 01-029/13
	Last Issued: 11/27/2013

2014 Mazda6 vehicles with VINs lower than JM1 GJ ***** 149082 (produced before October 01, 2013)

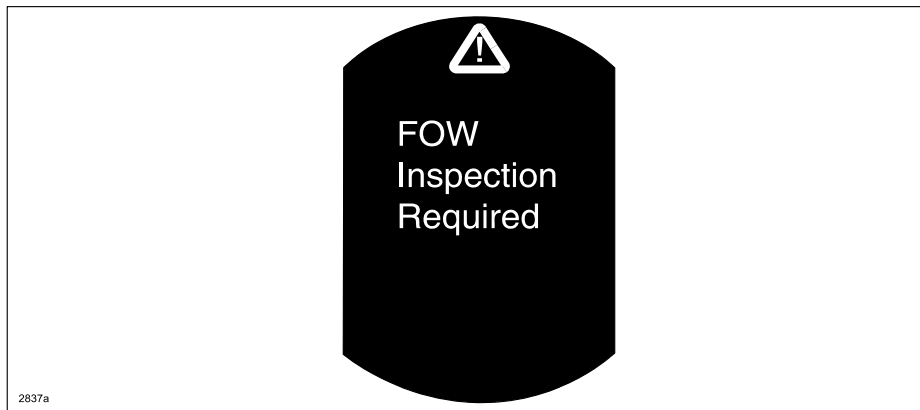
Some customers may experience a MRCC malfunction when driving long distances with MRCC set. Instrument cluster information display shows "FOW INSPECTION REQUIRED" and DTC C1A67:78 (Radar sensor axis is deviated) is stored. This is caused by MRCC no obstacle detection during a long drive.

Customers having this concern should have their vehicle repaired using the following repair procedure.
