Subject: TOMTOM NAVIGATION FUNCTIONALITY CONCERNS	Bulletin No: 09-035/13
	Last Issued: 11/25/2013

- 2013 Mazda3 (with TOMTOM navigation)
- 2014 Mazda6 (with TOMTOM navigation)
- 2013-2014 CX-5 (with TOMTOM navigation)
- 2013 CX-9 (with TOMTOM navigation)

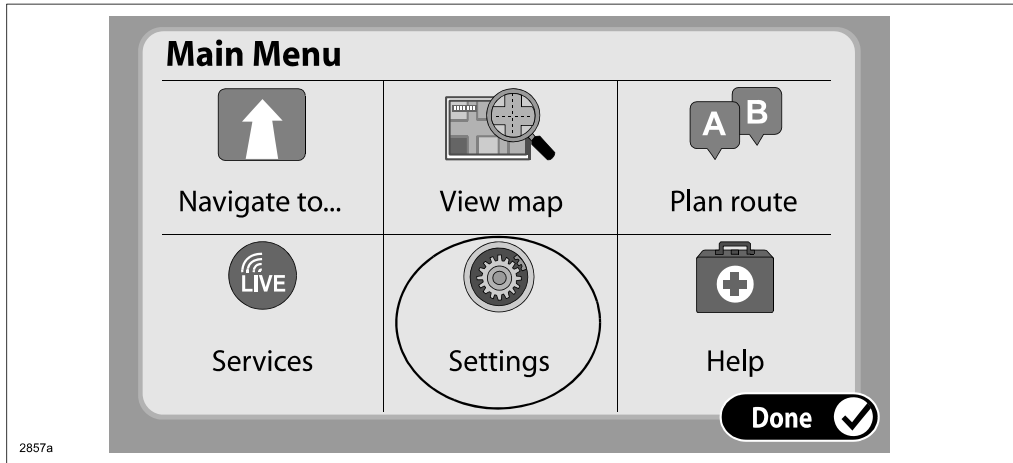
1. Tap the screen.
2. Select "Settings."

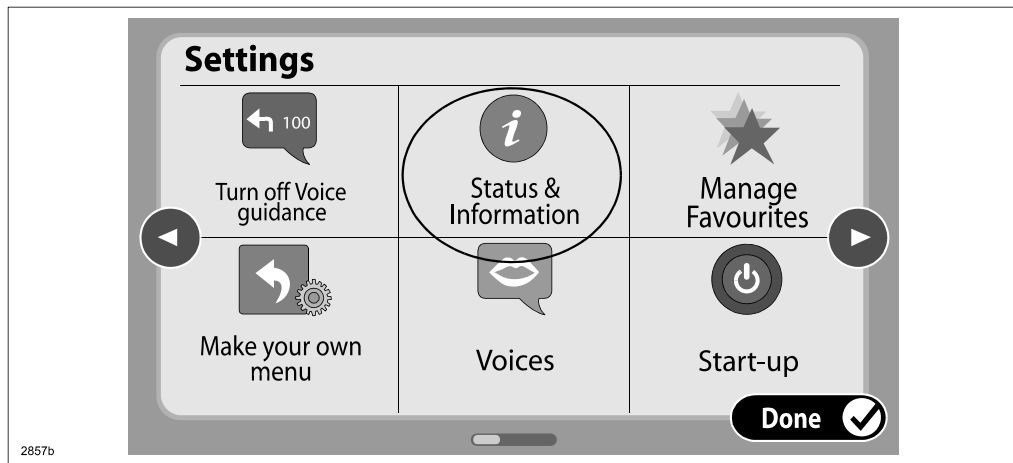
3. Select "Status and Information."

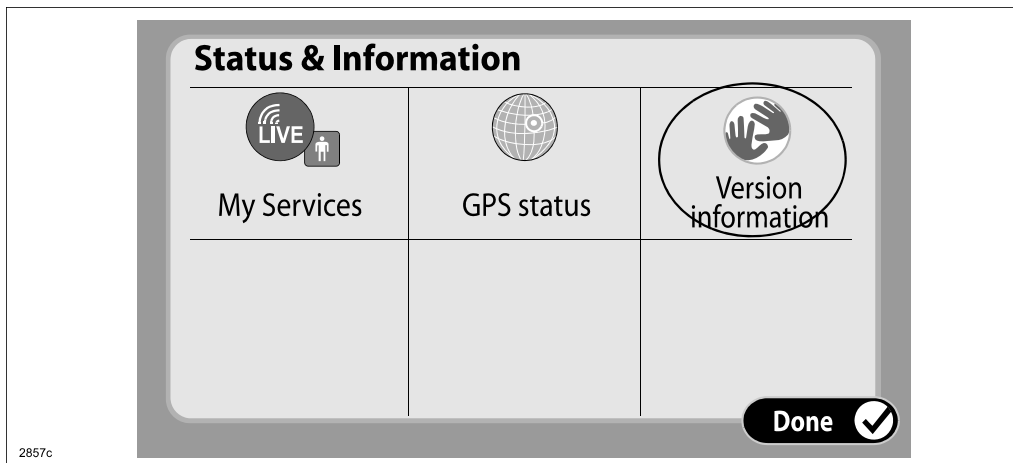
4. Select "Version Information."

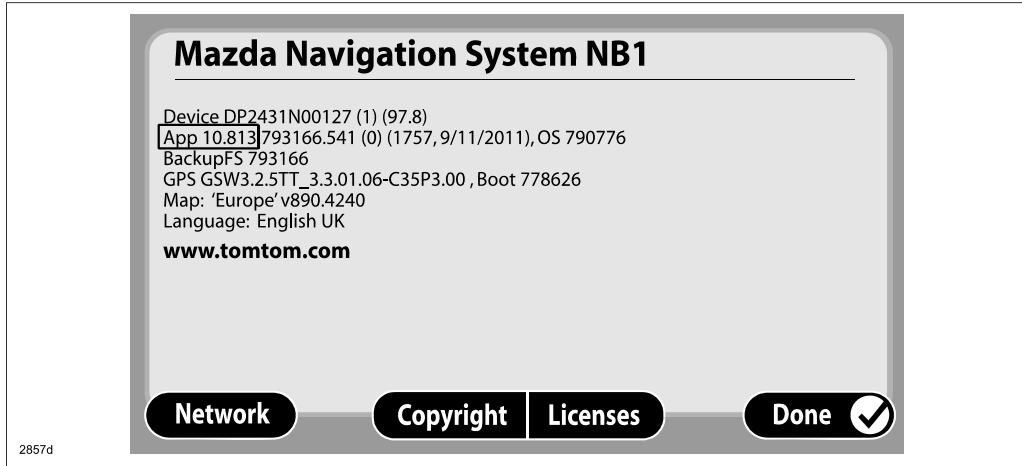
- Verify that the software version is 10.850 or higher. If it is 10.850 or higher, no update is needed.

When you encounter a customer complaint on any of these concerns, confirm the software version of the navigation unit by referring to "Checking the Software Version of the Navigation System" below. If the software version is older than 10.850, ask the customer to update the software through TOMTOM Home. If the customer will not update the software through TOMTOM Home, replace the navigation unit with an exchange unit.

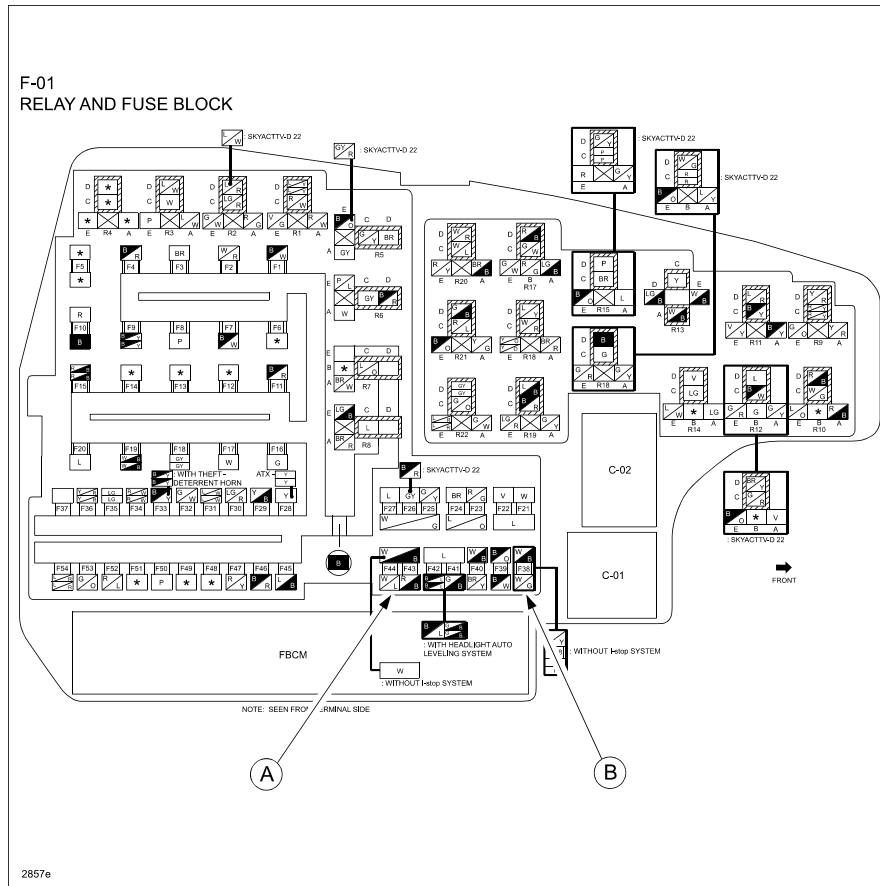
- Switch the ignition OFF and remove the Audio Fuse 1 (15A F44) (A) and Audio Fuse 2 (7.5A F38) (B) for about 5 minutes.

- After re-inserting both fuses and switching the ignition ON, the TOMTOM navigation unit will reboot completely including reading software from SD-card. When you push the NAV button, you will see a black screen with the TOMTOM logo on it after a short period of time.
