| Subject: LIFTGATE LATCH HANDLE GASKET PEELING OR HANGING LOOSE | Bulletin No: 09-033/13 |
| | Last Issued: 11/19/2013 |

2010-2011 Tribute

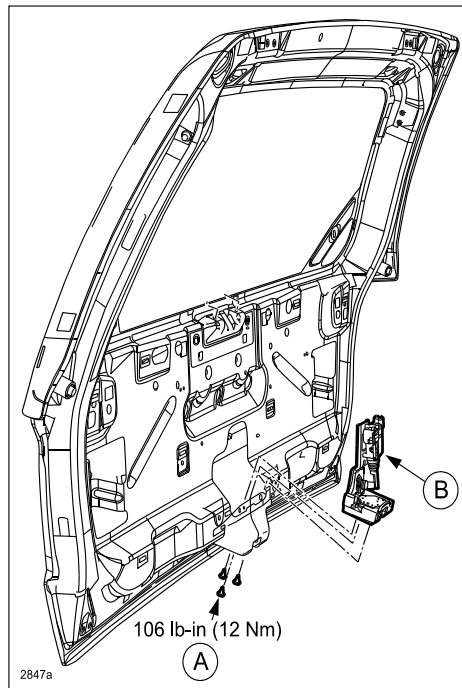
Some vehicles may exhibit a condition with the liftgate latch handle gasket peeling or hanging loose. Customers having this concern should have their vehicle repaired using the following repair procedure.

1. Verify customer concern.
2. Remove the liftgate trim panel. Refer to MS3 online or Workshop Manual (section 09-17 LIFTGATE TRIM PANEL REMOVAL/INSTALLATION).
3. Disconnect the liftgate latch electrical connectors.
4. Remove and discard the 3 liftgate latch bolts (A).
Tightening Torque: 106 in-lb (12 Nm)
5. Remove the liftgate latch assembly (B).
