Service Bulletin

Subject: MIL ILLUMINATION WITH DTCs P219A:00 AND/OR P219B:00	Bulletin No:	01-027/13
	Last Issued:	11/12/2013

2011-2013 CX-9

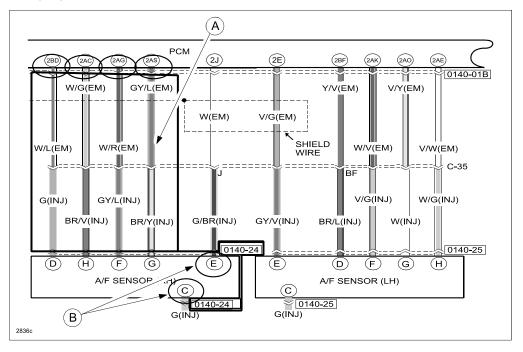
Wiring Diagram:

- (A) = Install short cord
- (B) = A/F Sensor (RH) terminals C and E

- 1. Verify that DTC P219A:00 is stored in PCM memory.
- 2. Record the customers preset radio stations.
- 3. Remove the engine cover.
- 4. Disconnect the negative battery cable.
- 5. Remove the battery and battery tray.
- 6. Remove the air cleaner element assembly.
- DTC P219A:00 only: Remove the resonance chamber (A) and dynamic chamber (B) according to MS3 online instructions or the Workshop Manual (section 01-13 INTAKE-AIR SYSTEM REMOVAL/INSTALLA-TION [MZI-3.7]).

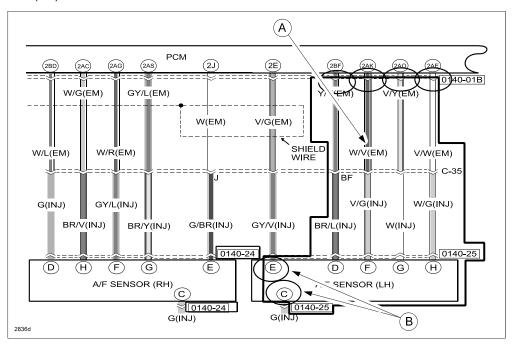
Wiring Diagram:

- (A) = Install short cord
- (B) = A/F Sensor (LH) terminals C and E

- 1. Verify that DTC P219B:00 is stored in PCM memory.
- 2. Record the customers preset radio stations.
- 3. Remove the engine cover.
- 4. Disconnect the negative battery cable.
- 5. Remove the battery and battery tray.
- 6. Remove the air cleaner element assembly.
