Subject: RATTLING NOISE FROM CENTER SEAT BACK WHEN DRIVING ON ROUGH ROADS	Bulletin No: 09-032/13
	Last Issued: 11/11/2013

2013-2014 CX-5 vehicles equipped with a 4:2:4 split type rear seat with VINs lower than JM3KE*****327345 (produced March 1, 2013)

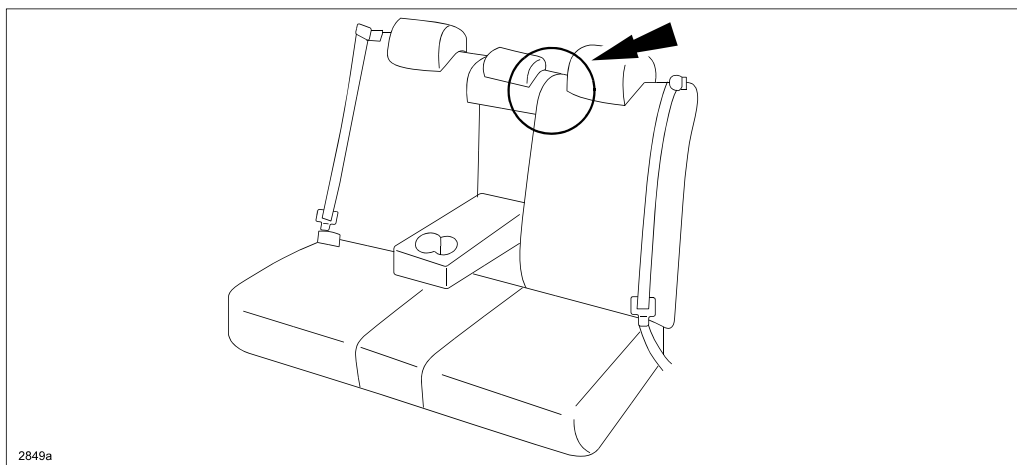
Some vehicles, equipped with a 4:2:4 split type rear seat, may exhibit a rattling noise when driving on rough roads. The noise is heard around the latch area of the rear center seat back, as shown below.

This concern may be caused by a rubber stopper that has come off the rear center seat back bracket. The seat bracket contacts the striker and causes the noise.

The shape of the rubber stopper and center seat back bracket have been changed to eliminate the noise.
