Subject: VARIOUS ELECTRICAL SYSTEM MALFUNCTION(S) RELATED TO C-15 CON- NECTOR CORROSION	Bulletin No: 09-031/13
	Last Issued: 11/11/2013

2013-2014 CX-5 vehicles with VINs lower than JM3KE*****365953 (produced before June 25, 2013)

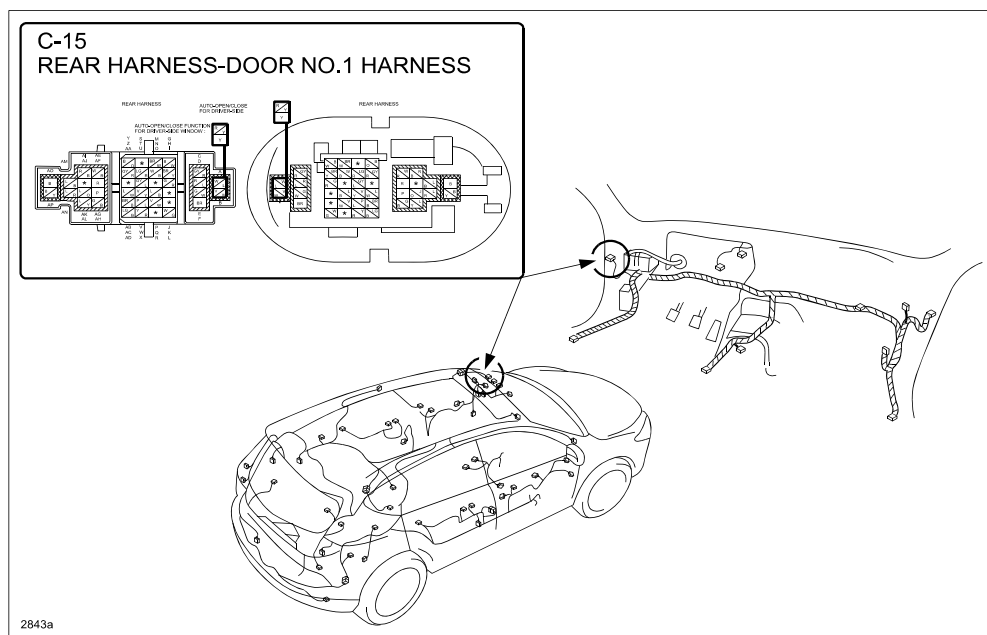
- The driver side power window does not operate.
- The door does not open when using the advanced keyless system.
- The warning lamp stays ON even after the ignition switch is turned OFF.

The symptoms listed above may be caused by corrosion of the C-15 connector terminals due to water intrusion through the front door. In low ambient temperatures, the door harness hardens. If the door is fully opened, it may create a gap between the door and the door harness grommet, which may allow water to enter through the gap.

- The front door harness grommet has been changed to improve sealing performance.
- Holes inside the front pillar (which are made for weight reduction), have been covered to prevent water intrusion.

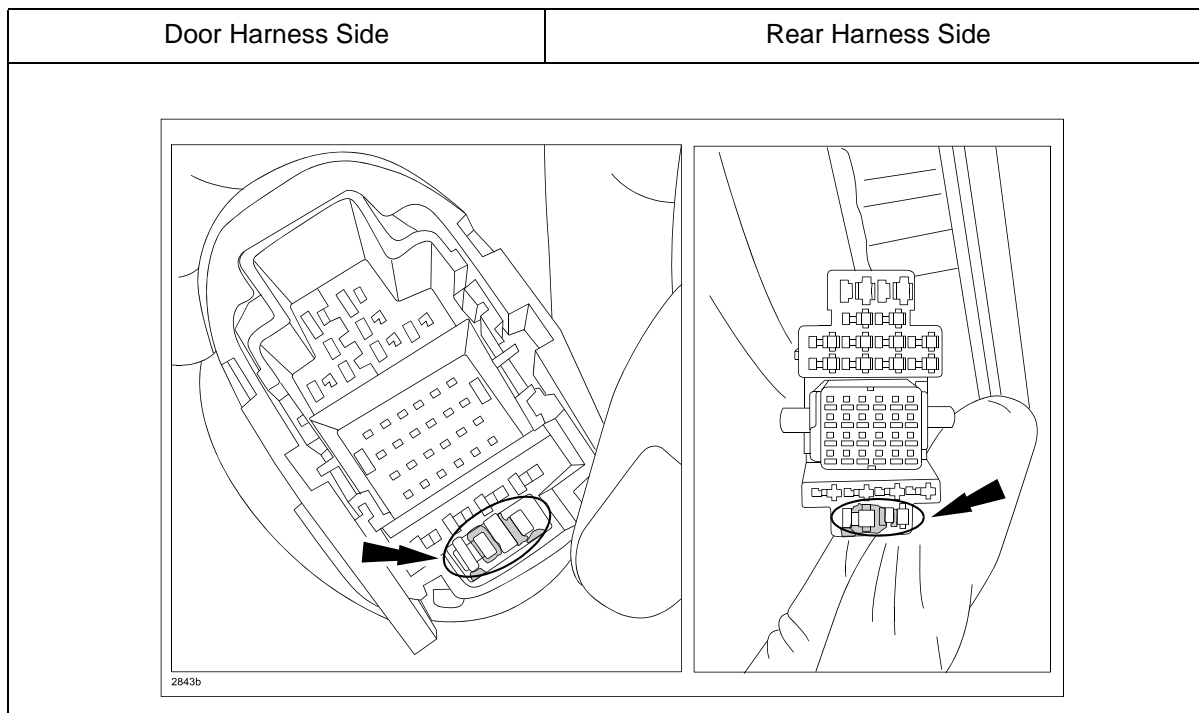
- If there is any corrosion at the C-15 connector, replace the door harness and repair the rear harness according to the following repair procedure.
 - If there is no corrosion found at the C-15 connector, this bulletin is not applicable. Troubleshoot the concern(s) according to the MS3 online instructions or the Workshop Manual.
1. Verify the customer concern.
 2. Record customers pre-set radio stations.
 3. Slide the driver side front seat fully backwards.
 4. Disconnect the negative battery cable.
 5. Disconnect the C-15 connector according to the MS3 online instructions or the Workshop Manual (section 09-11 FRONT DOOR REMOVAL/INSTALLATION).
 6. Inspect for any corrosion found on the terminals shown below.

- If there is any corrosion found on the terminals, go to next step.
 - If there is no corrosion found on the terminals, this bulletin is not applicable. Troubleshoot the concern(s) according to the MS3 online instructions or the Workshop Manual.
7. Remove the driver-side front side trim according to the MS3 online instructions or the Workshop Manual (section 09-17 FRONT SIDE TRIM REMOVAL/INSTALLATION).
 8. Remove the hood release lever from the under panel according to the MS3 online instructions or the Workshop Manual (section 09-14 HOOD LATCH AND RELEASE LEVER REMOVAL/INSTALLATION).
