<b>Subject:</b>  <b>KNOCKING / SQUEAKING NOISE FROM FRONT STRUT BEARING</b>	<b>Bulletin No:</b> 02-005/13
	<b>Last Issued:</b> 11/11/2013

## BULLETIN NOTE

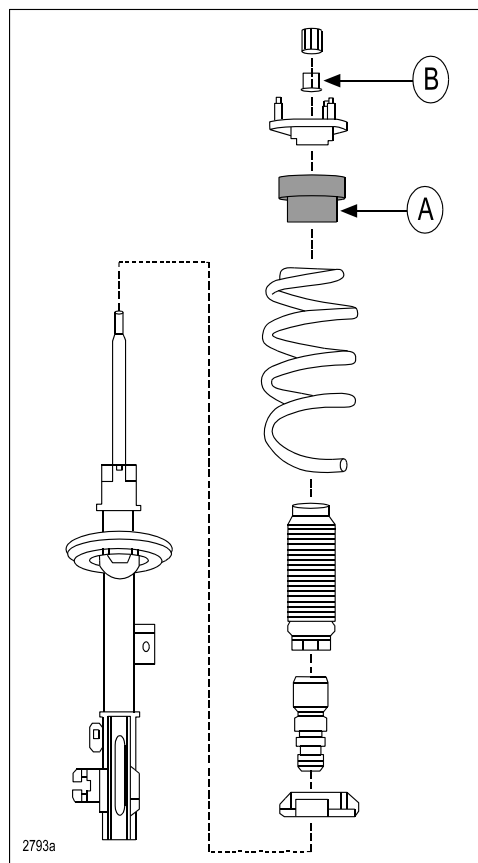
Some vehicles may exhibit a knocking / squeaking noise from the front strut bearing (A) due to front strut bearing damage when driving on rough roads and/or when turning the steering wheel while the vehicle is stopped.

The noise may be due to the upper housing of the front strut bearing being damaged when applying excessive force to the bearing during customer use. To eliminate the noise, the material and production method of the front strut bearing has been changed.

**NOTE:** The piston rod nut (B) requires replacement when the front strut bearing is replaced.

5. Using ChassisEAR SST, is the noise is coming from the upper part of front shock absorber?
- Yes - Proceed to step 6.
  - No - This bulletin does not apply.
6. Replace the front strut bearing with a new one according to MS3 online instructions or the Workshop Manual (section 02-13 FRONT SHOCK ABSORBER AND COIL SPRING DISASSEMBLY/ASSEMBLY).
7. Verify repair.

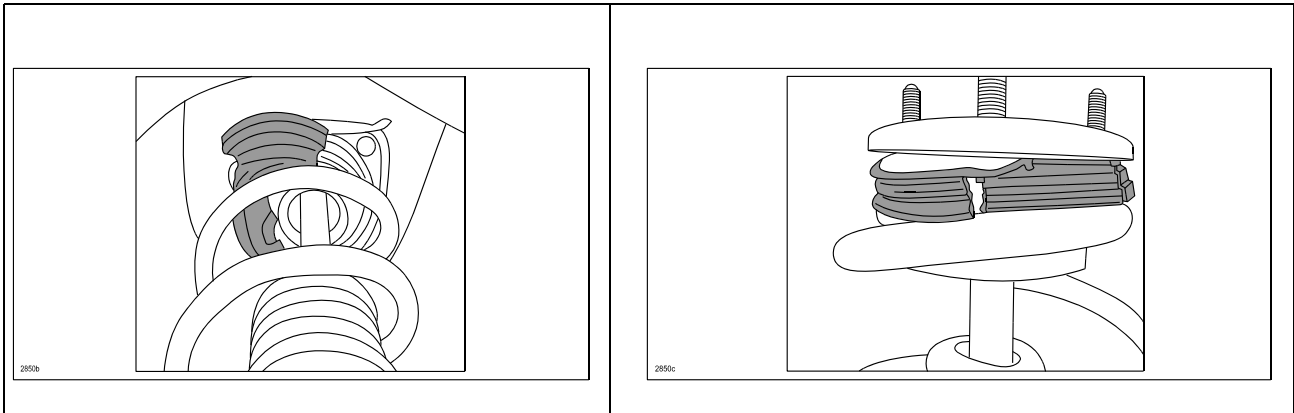
1. Verify customer concern.
2. Is the noise is coming from the upper part of front shock absorber when turning the steering wheel?
  - Yes - Proceed to step 3.
  - No - This bulletin does not apply.
3. Is the strut bearing broken as shown below?
  - Yes - Proceed to step 6.
  - No - Proceed to step 4.

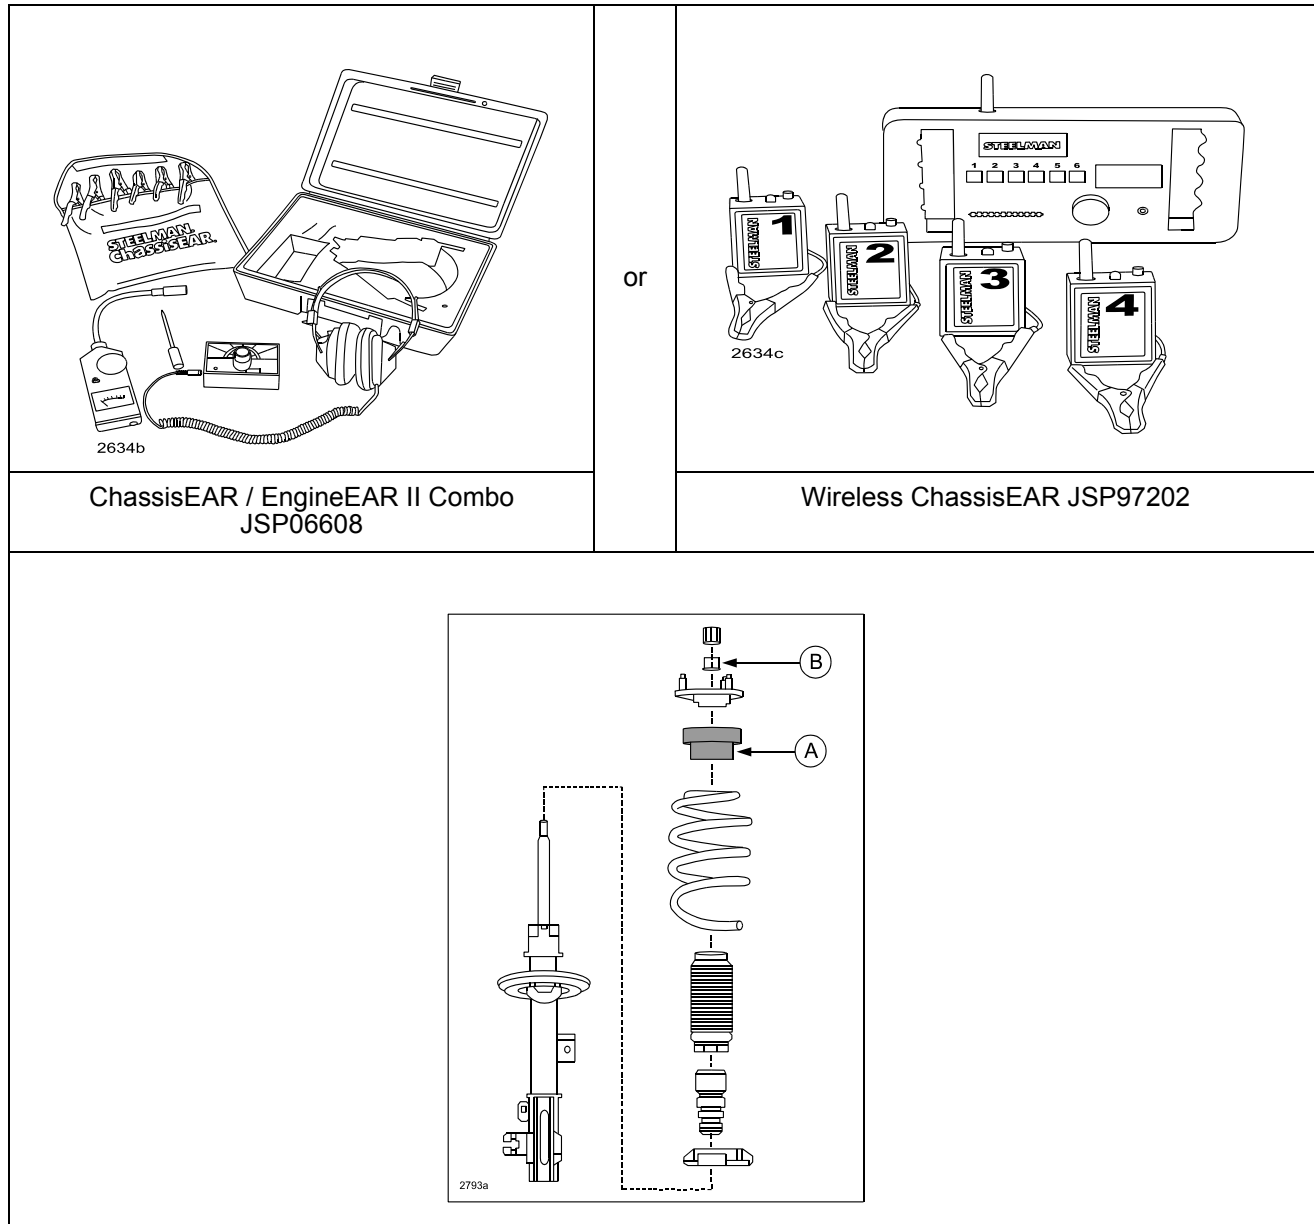
4. Use Special Service Tool (SST) ChassisEAR / EngineEAR II Combo JSP06608 or Wireless ChassisEAR JSP97202 to confirm noise is coming from the upper part of front shock absorber (A) (shown below):
