Subject: CHIRP NOISE FROM RIGHT REAR AT 60 MPH OR MORE	Bulletin No: 09-001/13
	Last Issued: 11/11/2013

2013-2014 CX-5 vehicles with VINs lower than JM3KE*****358081 (produced before June 3, 2013)

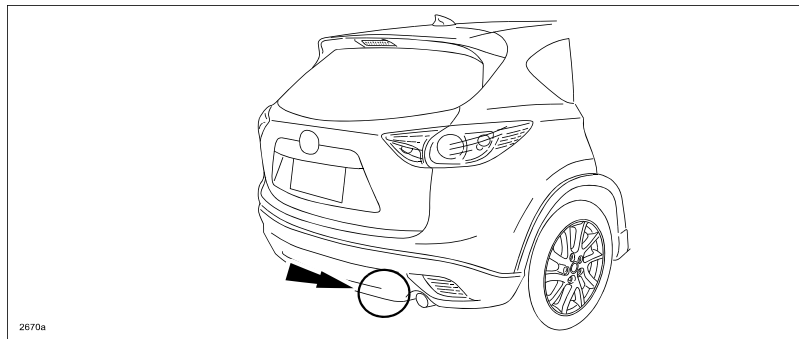
While driving at approx. 60 mph or more, some vehicles may exhibit a chirp noise from rear right end of the vehicle.

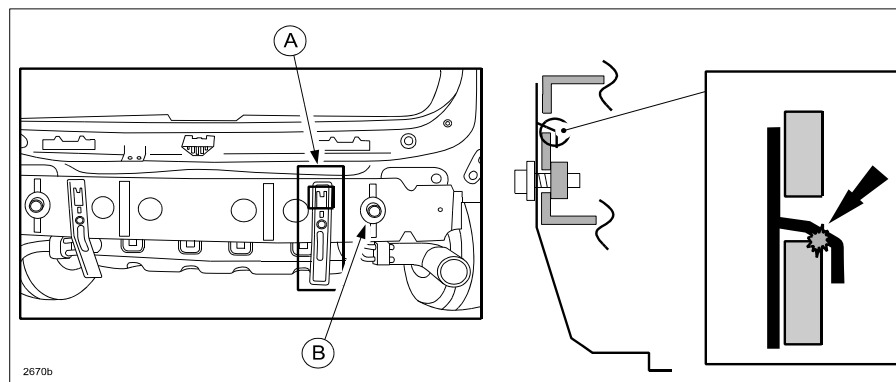
The chirp noise may be caused by the right side rear bumper stay hook (A) contacting the bumper reinforcement (B) at high speed. The shape of the reinforcement hole has been changed on both sides to eliminate the noise. Also, pads have been added to the bumper stay to prevent contact noise.

Customers having this concern should have their vehicle repaired using the following repair procedure.

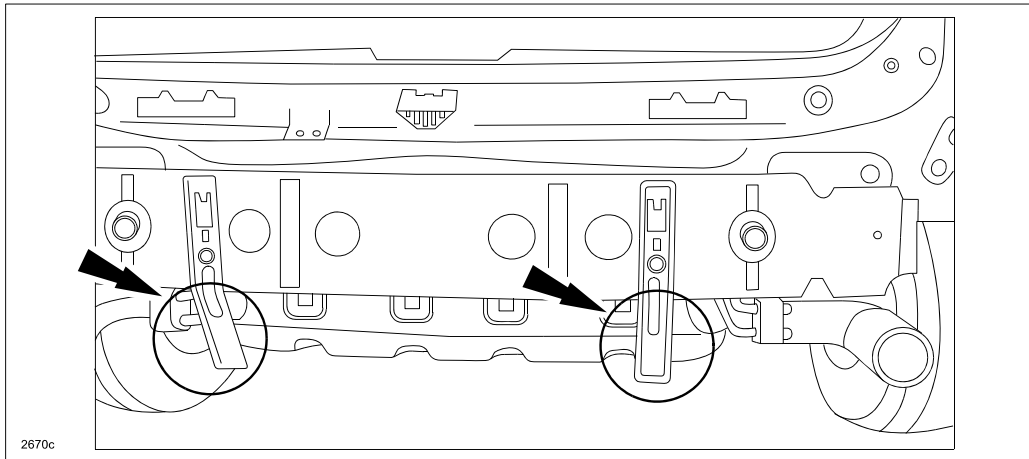
1. Verify the customer concern by lightly tapping the left and right sides of the rear bumper by hand.
 - If the noise is heard on either side, follow the repair procedure below to eliminate the concern.
 - If the noise is not heard on either side, this service bulletin is not applicable.
2. Remove the rear bumper from the vehicle according to the instructions on MS3 online or the Workshop Manual (section 09-10 REAR BUMPER REMOVAL/INSTALLATION).
3. Confirm the chirp noise again by hitting the lower side of left and right bumper stays by hand.

NOTE: Even if there is no chirp noise on the left side, perform the repair on both sides.
