Subject: REAR DOOR WEATHERSTRIP OUT OF POSITION	Bulletin No: 09-029/13
	Last Issued: 11/05/2013

2014 Mazda6

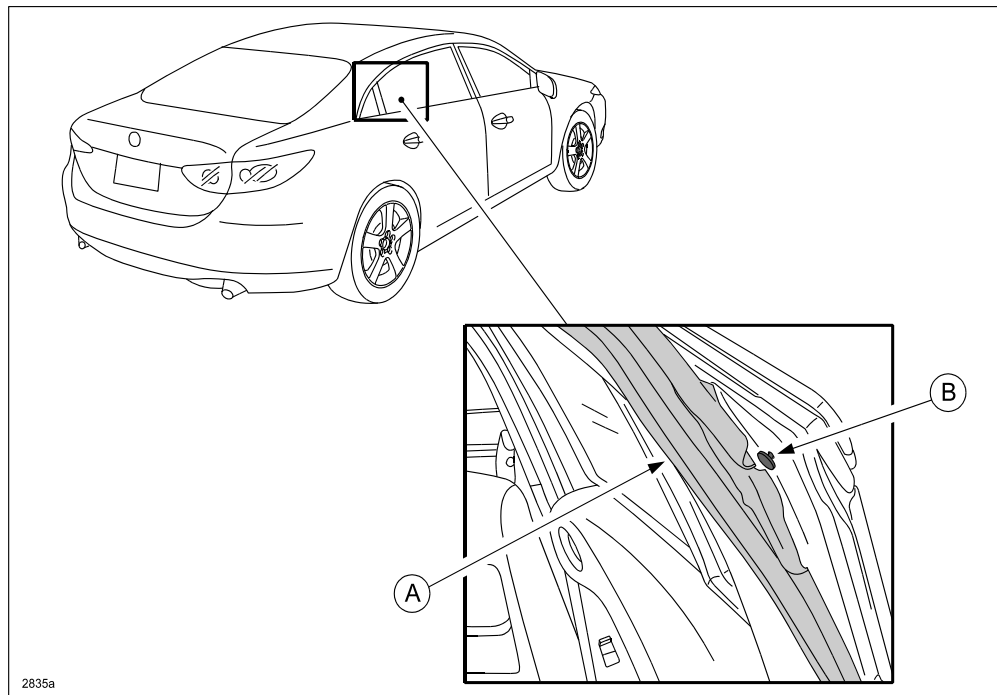
Some customers may have a concern with the top edge of the rear door weatherstrip (A) detached from fastener (B).

Customers having this concern should have their vehicle repaired using the following repair procedure.

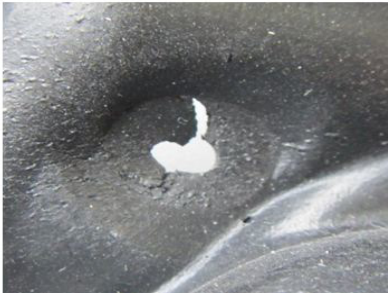
Cracked, replace weatherstrip.	Damaged, but not cracked completely.

1. Verify if the weatherstrip fastener hole is not cracked as shown below. If cracked as shown "NG", replace weatherstrip. If damaged, but not cracked completely as shown "OK", reuse old weatherstrip.
