# Service Bulletin

## PRELIMINARY INFORMATION

**Subject:** (EREV) Whine Scrape Whistle Type Noise While Driving

**Models:** 2011-2014 Chevrolet Volt

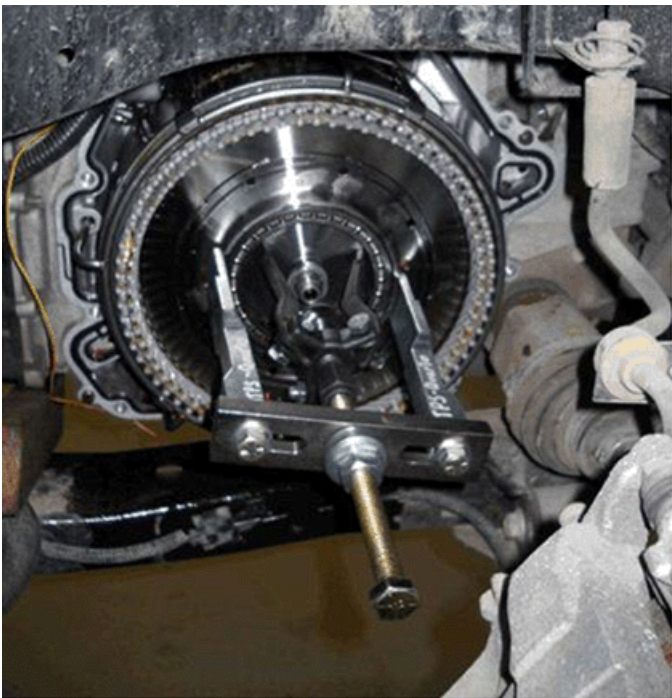
This noise may be caused by a separated electric drive motor B rotor bearing cage. A revised bearing has been released for installation into the drive unit. It is not necessary to remove the drive unit or motor for this repair. Follow SI (Document ID 2838728) on vehicle service, drive motor rotor bearing replacement procedure. During repairs inspect the end cover for any abnormal bushing wear, if found the side cover will also require replacement, however if no abnormal wear is found the cover can be reinstalled.

**Important:** Please ensure that the Special Tools DT-47865 - Bearing Remover and J-45124 - Removal Bridge are used to remove bearing. If proper tools are not used the rotor may be damaged leading to a repeat repair. **DO NOT TRY TO PRY OUT.**
