Service Bulletin

PRELIMINARY INFORMATION

Subject: (EREV) Whine, Scrape, Whistle Type Noise While Driving

Models: 2011-2014 Chevrolet Volt

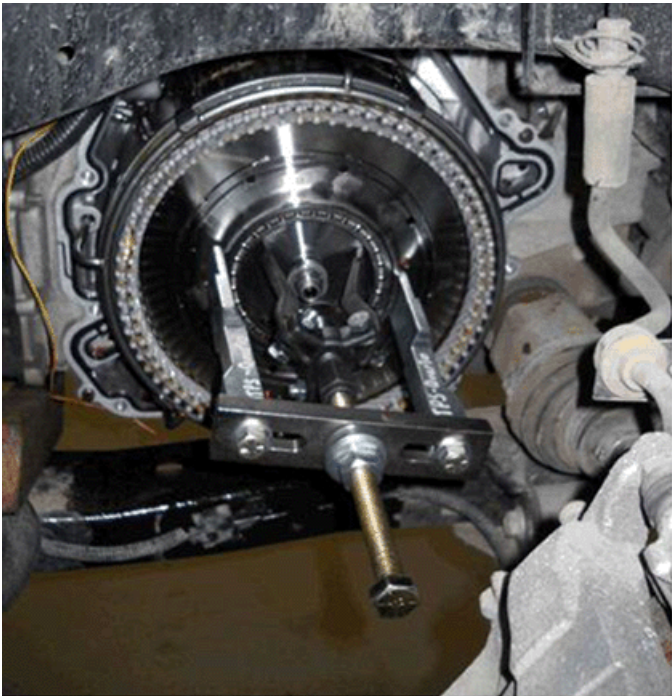
Some customers may comment on a whistle, scrape or whine type noise while driving that may be more noticeable during regenerative braking. Technicians may find this noise emanating from the left side of the drive unit (transmission). The tech may also state that the vehicle has a current or history code P0A46.

This noise may be caused by a separated electric drive motor B rotor bearing cage. A revised bearing has been released for installation into the drive unit. It is not necessary to remove the drive unit or motor for this repair. Follow SI (Document ID 2838728) on vehicle service, drive motor rotor bearing replacement procedure. During repairs inspect the end cover for any abnormal bushing wear, if found the side cover will also require replacement, however if no abnormal wear is found the cover can be reinstalled.

Important: Please ensure that the Special Tools DT-47865 - Bearing Remover and J-45124 - Removal Bridge are used to remove bearing. If proper tools are not used the rotor may be damaged leading to a repeat repair. **DO NOT TRY TO PRY OUT.**
