Service Bulletin

Subject: Allison LCT1000 Range Inhibit Or No Forward Reverse P0701 P0729 P0731 P0732 P0733 P0734 P0735 P0751 P0756 P0761 P0877 Or P2723 May Be Set

Models: 2011-2014 Chevrolet Silverado
2011-2014 GMC Sierra

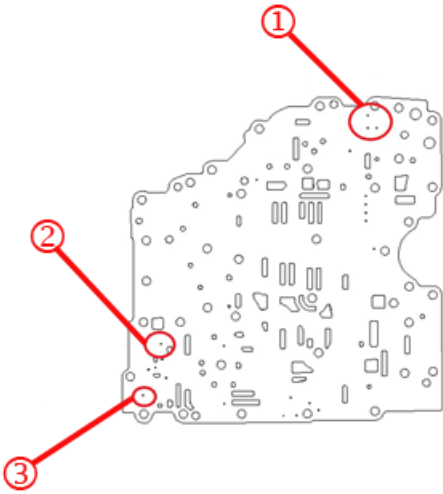
This can contribute to a condition where the valve body separator plate orifices can become plugged.

- Modulated main feed orifice- P0701 P0729 P0731 P0732 P0733 P0734 P0735 P0751 P0756 P0761 may set if this orifice is blocked.
- PCS1 feed hole-An intermittent or no reverse condition can be exhibited when the PCS1 feed is blocked along with P2723 setting.
- Reverse pressure orifice-Drive range may be inhibited along with P0877 setting.

The most common areas of blockage are shown in the picture below.

Call out 1
Reverse Pressure Orifice.

Call out 2
Modulated main feed orifice.

Call out 3
PCS1 Feed.

Always closely inspect the separator plate for this condition anytime the valve body is removed.

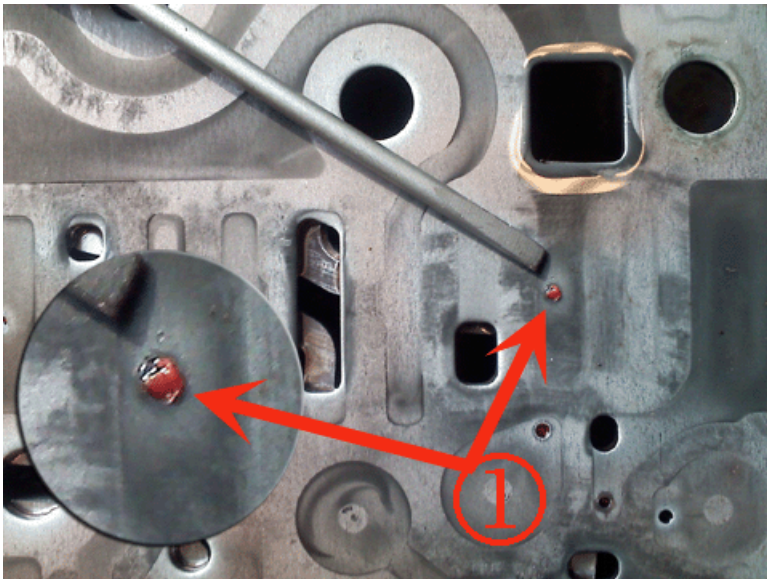
Many aftermarket spin-on filters are shipped with a protective shrink-wrap packaging that may inadvertently be introduced into the transmission during filter installation.

Call out 1
Example of blockage.
