Service Bulletin

PRELIMINARY INFORMATION

Subject: Cold Start Misfires

Models: 2012-2014 Buick LaCrosse
2013-2014 Cadillac ATS
2012-2014 Cadillac CTS
2012-2014 Cadillac SRX
2013-2014 Cadillac XTS
2012-2014 Chevrolet Camaro
2012-2014 Chevrolet Caprice PPV
2012-2014 Chevrolet Captiva Sport
2012-2014 Chevrolet Equinox
2012-2014 Chevrolet Impala
2012-2014 GMC Terrain
with 3.0 LF1 or LFW and 3.6 LFX

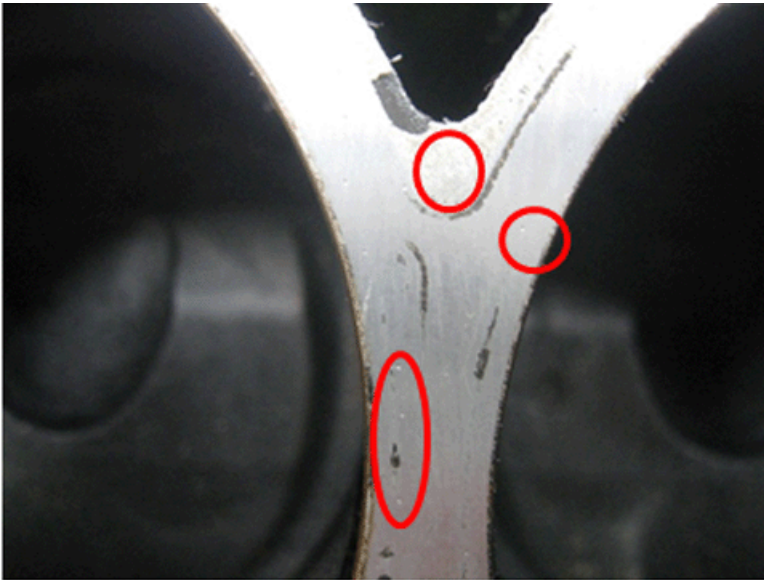
See pictures below for examples of deck pitting and actual porosity with leak path.

Small surface pock marks or pitting appearance on the deck surface is normal and engines should not be replaced for such appearance as they do not connect to coolant passages and cause a leak path that generate engine misfires.

During engine warranty analysis studies, engines are being replaced for small pitting in the deck face as described above, when the subject cylinder / piston is saturated with fuel and not coolant.

Engine replaced for subject pitting conditions will be returned to the dealership as non defective.
