Service Bulletin

PRELIMINARY INFORMATION

Subject: Spark EV Chevrolet Volt Opel Ampera Models With Or Without Service Vehicle Soon Lamp - SVS - or Check Engine Lamp On With DTC P0534 Set Current Or History

Models: 2011 - 2014 Chevrolet Volt
2014 Chevrolet Spark EV
2012 - 2014 Opel Ampera

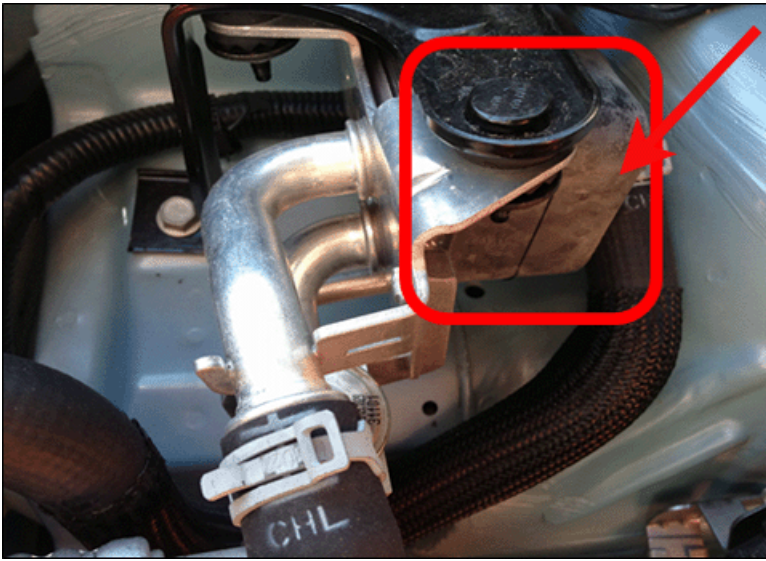
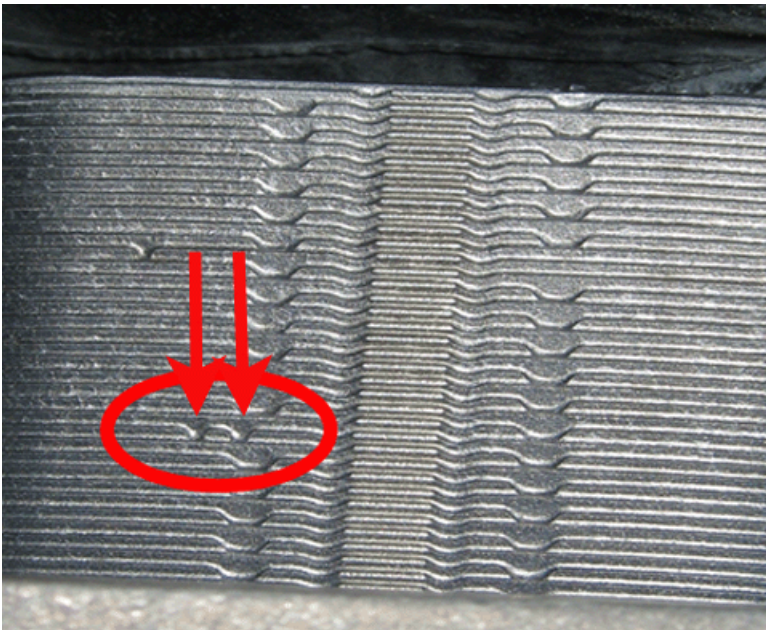
Note: Shown below is a picture of the RESS Cooler from the Spark EV. The black insulator cover can be easily pulled back to inspect the Cooler Plate notches without removal.

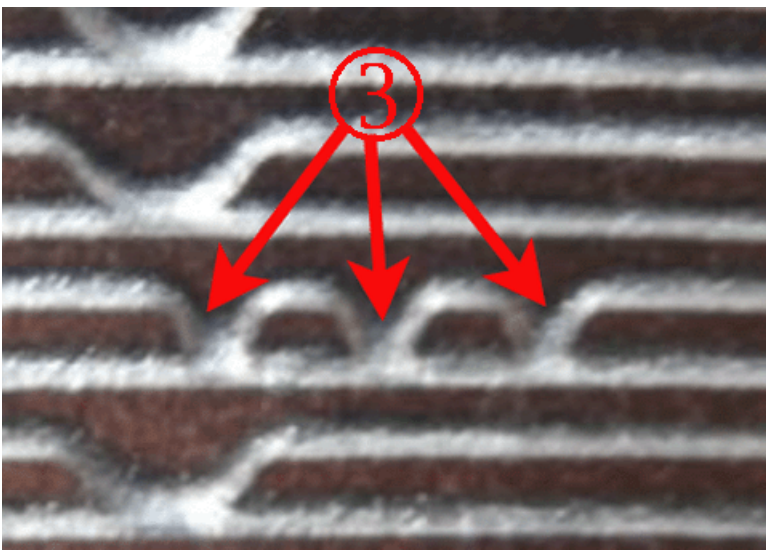
3 Notches equals replace cooler.

4. The RESS Cooler passes inspection if the RESS Cooler has two notches. If there are three notches, replace the RESS Cooler. (See photos below).
5. If the vehicle build does not fall within the suspect date range, continue to operate the vehicle with GDS2 connected.

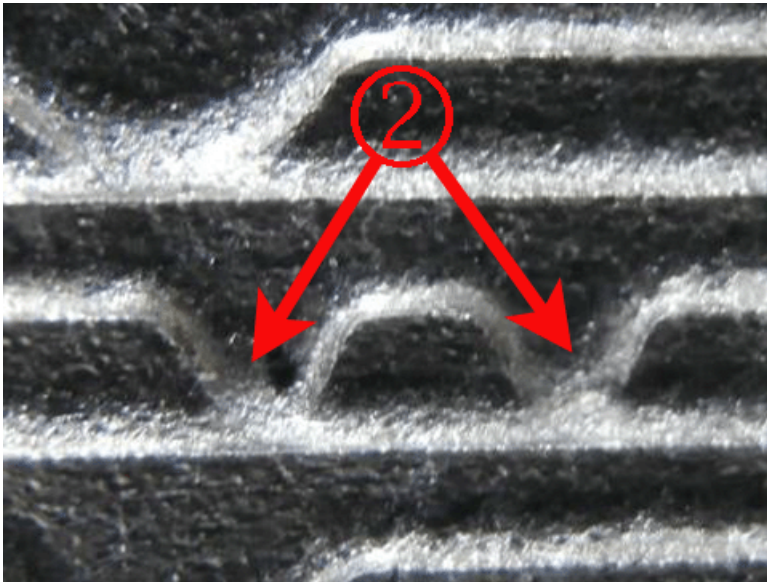
2 Notches equals DO NOT replace cooler.
