Service Bulletin

PRELIMINARY INFORMATION

Subject: Possible Oil Leak On Gen 5 Engine After The Harmonic Balancer Is Removed Or Replaced

Models: 2014 Chevrolet Corvette
2014 Chevrolet Silverado 1500
2014 GMC Sierra 1500
Built with RPOs 4.3L 5.3L 6.2L L83 L86 LT1 LV3

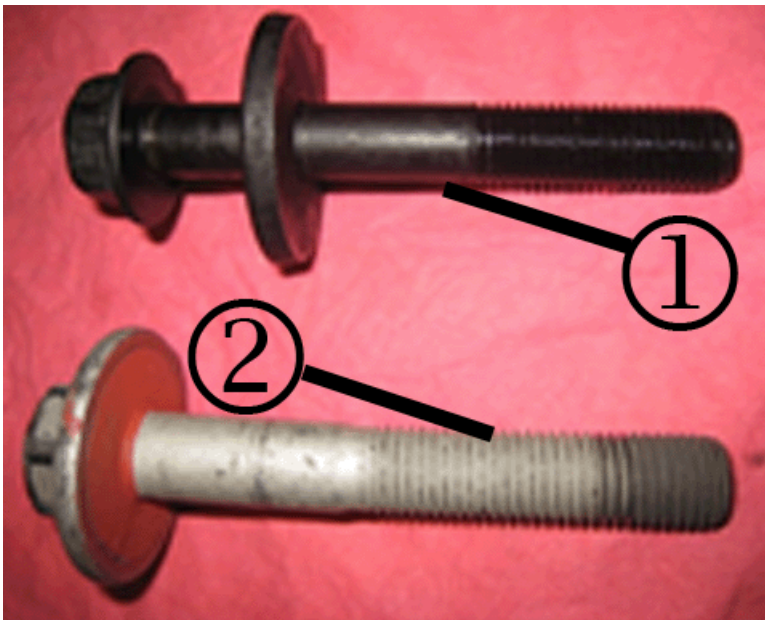
- Gen 4 engines use a non-keyed Harmonic balancer. The only part of the crank that is keyed drives the oil pump. The bolt has a friction material on the face. It does not seal the Harmonic Balancer to the crank.
- Gen 5 engines use a keyed Harmonic Balancer that can see oil pressure. It uses a two piece bolt and washer arrangement. It does seal to the face of the crank.

Note: If you use a Gen 4 bolt in a Gen5 engine you will have an oil leak.

1- is for a gen 5 engine

2- is for a gen 4 engine
