# Service Bulletin

## PRELIMINARY INFORMATION

**Subject:** Cylinder Head Tick Noise And/Or Damage - Possible Plugged Oil Feed Orifice

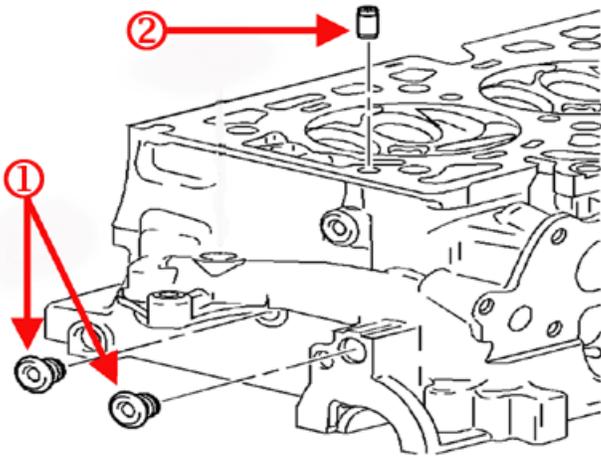
The cylinder head is equipped with oil feed orifice (2) that may become plugged with debris, such as excessive RTV/sealer or broken down oil filter material. If this occurs, this noise may occur as a result of no/low oil pressure to the valve train.

- 5.2. If the upper end oil pressure is near 0 PSI/KPA but the lower end oil pressure is within SI specification, the oil feed orifice (2) is most likely plugged with debris. Please note that it is not uncommon for the upper end oil pressure of a normally functioning engine at idle to measure as much 35% less than the bottom end oil pressure. This is due to the large amount of oil pressure bleed off that normally occurs in the valve train, combined with the small size of the oil feed orifice (2).

**Notice:** The oil gallery plug port threads (1) on the back of the cylinder head are M12x1.75 and it is unlikely that a related oil pressure gauge adapter will be found at a hardware or auto parts store. The 509376 Kent Moore Fitting that comes with the Engine Preluber Kit (EN-45299/J-45299) will screw into the head and may be adapted to some oil pressure gauges. Or, there are also several online retailers that can supply a fitting that will work as an adapter - the male end has to be M12x1.75 while the female end has to be 1/8"x27 NPTF so a standard oil pressure gauge hose can screw into it. It has also been found that some automotive gauge companies, such as Auto Meter, offer the necessary adapter/fitting (M12x1.75 / 1/8"x27 NPTF) for \$5-\$20. Some technicians have also reported success in making a temporary fitting out of an oil pressure sender body.

If you suspect a plugged oil feed orifice after performing the test above, remove the cylinder head and visually inspect the oil feed orifice (2) for debris. If debris is present, it can normally be cleaned out to repair the noise. Please note that the orifice is not available separate from the cylinder head and cannot be inspected/cleaned without cylinder head removal.

**Important:** To prevent future concerns, care must be taken not to use excessive amounts of engine sealant during internal engine repairs, use the proper oil filter that is listed in the parts catalog, and change the engine oil/filter according to the schedule in the owner's manual.
