# Service Bulletin

**Subject:** Intermittent No Crank No Communication To High Speed LAN Modules

**Models:** 2010 - 2013 Chevrolet Camaro

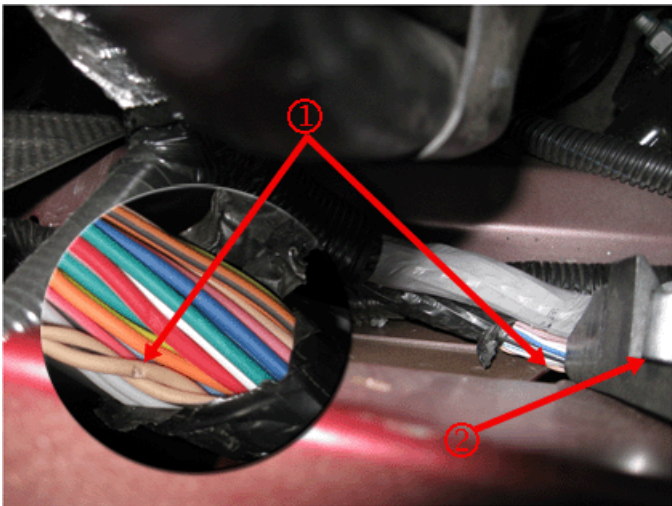
The first area of concern is the engine wiring harness (1) under the ECM (2). Technicians are to check for possible chaffing of this wiring harness on the inner fender panel. An example of this concern can be seen in the photo below.

Repair the wiring, install conduit on this area of the harness, and relocate the harness away from the panel to protect it from future damage.

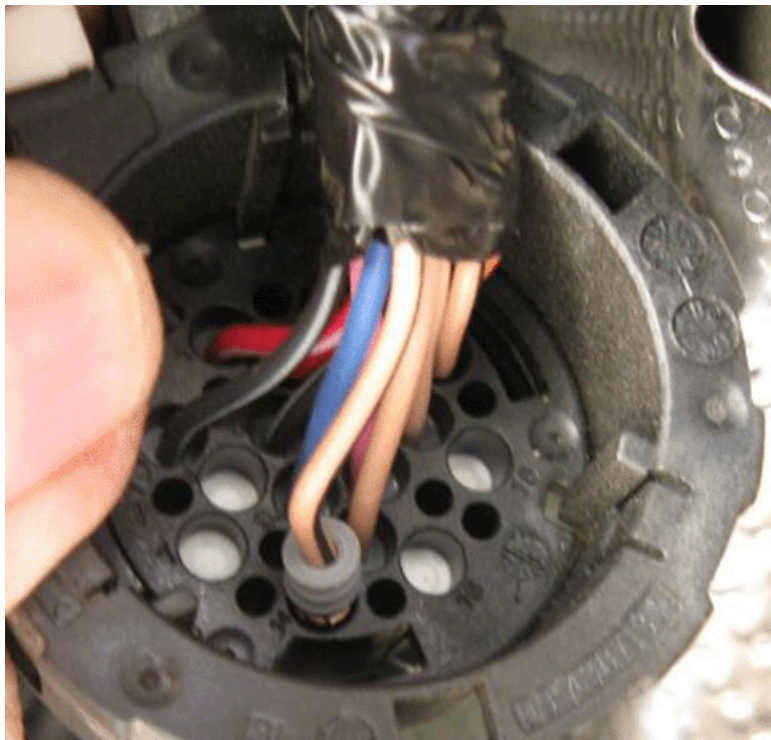
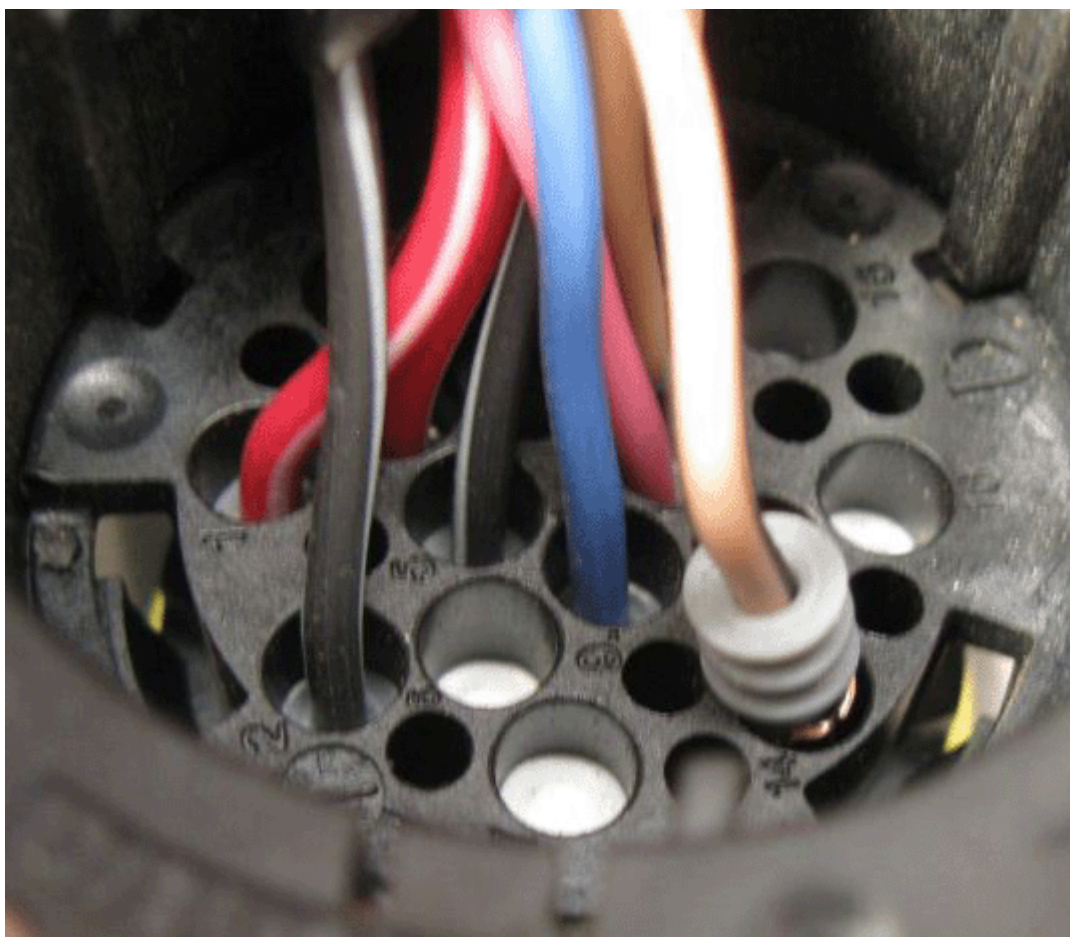
The second area of concern relates to vehicles equipped with an automatic transmission only. Reports from the field have shown that a HSLAN circuit terminal may not be seated properly in the round TCM connector located in the transmission. Technicians are to inspect this TCM connector for any data line circuits that may be not fully seated in the plastic connector. If this concern is found, carefully inspect the condition of both halves of the plastic connector as well as both the male and female terminals. If the female terminal was simply not seated correctly, push on the wire until the terminal clicks back into position. Lightly tug on the wire to make sure it is fully seated. If it pulls back out, replace the terminal and/or connector as needed. After reinstalling the connector to the TCM, lightly tug on the wire again to make sure it did not become disengaged during reassembly. If the male terminals or the TCM half of the connector is damaged, the entire TCM will require replacement. This module is internal to the automatic transmission assembly.

The two photos below show an example of circuit 2500 backed out of the TCM connector. Be sure to inspect ALL terminals in this connector while it is
