# Service Bulletin

Subject: Supplement to SI Timing Procedure for High Feature V-6 Engine

Models: 2013 Cadillac ATS

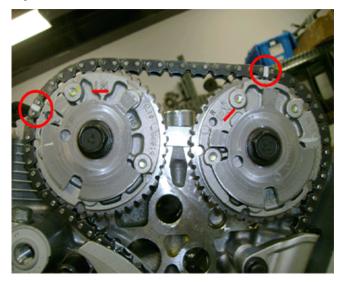
Start with engine in stage one position with tool EN 46105-1 or EN 48383-1 on the left bank or bank 2. The circular timing marks on the camshafts should be aligned as shown.

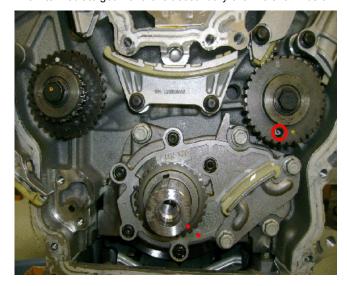
The intermediate gear for the left secondary chain is shown below. The painted link should be visible through the hole.

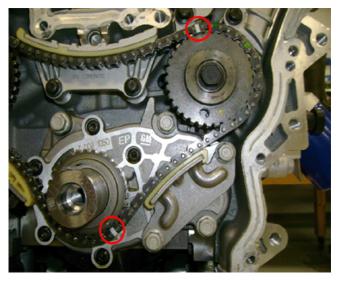
Stage one primary chain alignment for the crankshaft and the left intermediate gear are shown below. The intermediate gear has a triangular shaped timing mark that aligns with the painted link and the crankshaft has a dot to dot alignment.

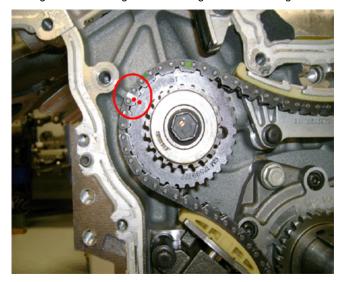
The right intermediate gear has a triangular mark that aligns with the painted link.

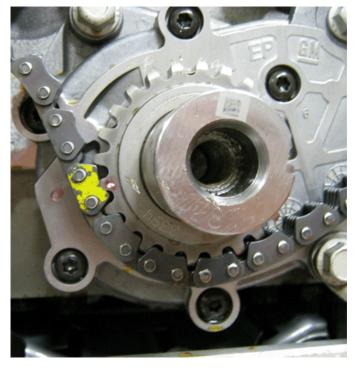
Remove EN 46105-1 or 48383-1 from the left bank. The engine will need to be rotated 115 degrees clockwise for stage two timing. The crankshaft marks should align dot to dot. Tool EN 46105-2 should fit easily on the rear of the cams on the left bank of the engine.

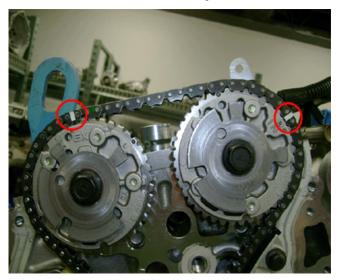
EN 48383-3 should be installed on the right bank or bank one. The triangular marks should be aligned as shown.

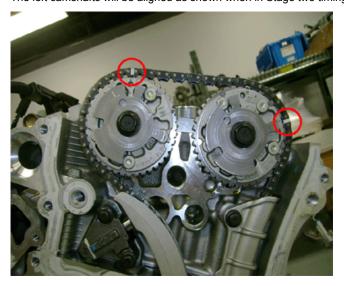
The left camshafts will be aligned as shown when in Stage two timing position.

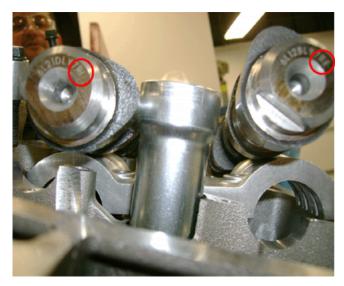
If there are any concerns in identifying the correct location for the camshafts check the number stamped in the rear of the camshaft RI is right intake, RE is right exhaust, LI is left intake and LE is left exhaust.
