Service Bulletin

PRELIMINARY INFORMATION

Subject: Possible Oil Consumption Or Blue Smoke From The Exhaust CEL Or Fuel Trim Codes

Models: 2013 Buick Encore
2011-2013 Chevrolet Cruze
2012-2013 Chevrolet Sonic
2013 Chevrolet Trax
With 1.4L (RPO LUJ or LUV)
With one or more of the following DTCs P0106 P0171 P0299 P0507 P1101 P2096

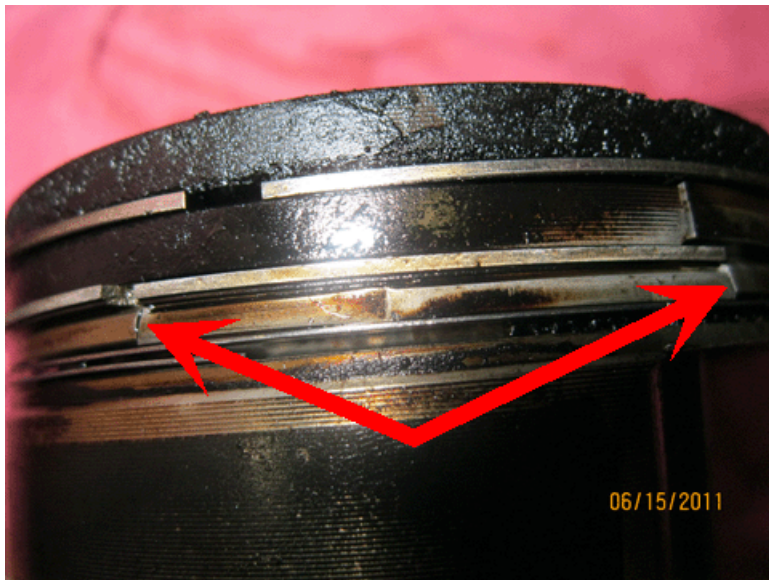
If no air leaks are found, remove all pistons and inspect ring condition and for cracks between the number 1 and 2 compression ring lands. See photo below:

Replace the pistons including new rings as needed using the latest part numbers in the catalog.

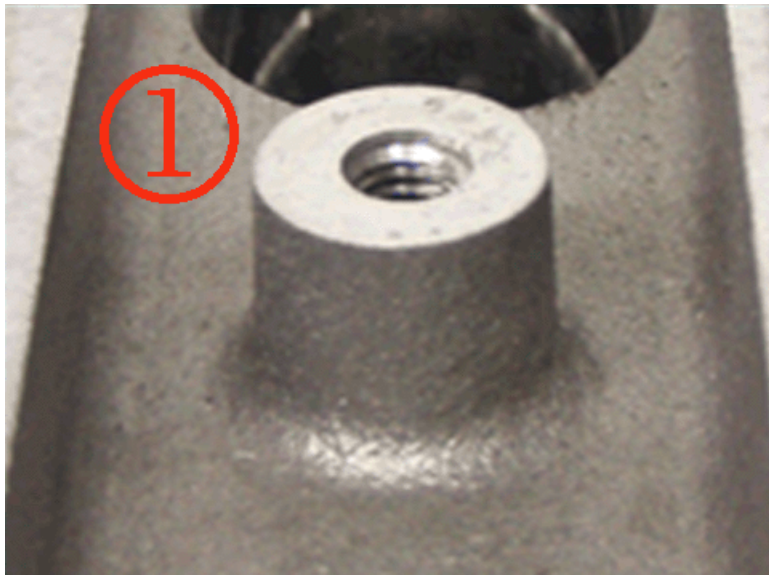
First design (call out #1)

If cracked piston ring lands are found, then inspect the cylinder head to determine first or second design. See photos below:

If the cylinder head is first design, then replace the cylinder head using the latest part number in the catalog.
