Service Bulletin

Subject: BAS+ (HYBRID) eAssist Charge Message On After A Collision Or Due To A Low Voltage Condition

Models: 2012 - 2013 Buick Lacrosse, Regal eAssist
2013 Chevrolet Malibu ECO eAssist
All with RPO HP6

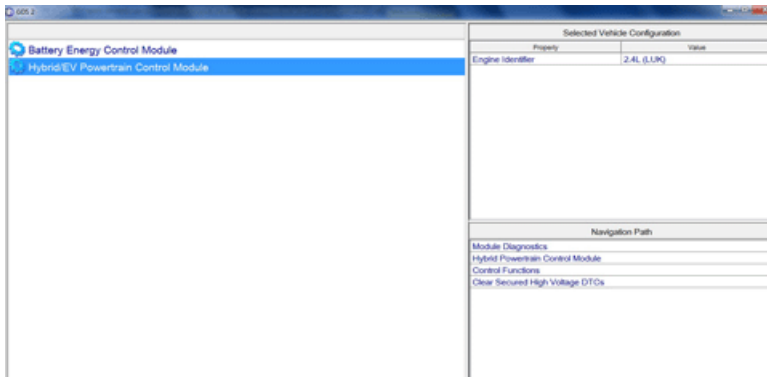
If this concern is encountered, connect GDS2 and ensure that engine identifier LUK has been selected as shown in the screen print below so the HPCM (Hybrid Powertrain Control Module) can be accessed to read hybrid DTCs. There may not be any DTCs set and all repairs may have been performed to repair the original concern. This concern may have occurred due to extremely low system voltage or may be the result of a vehicle collision that caused the contactors to open. There may not be a "crash event" detected on GDS2.

- If DTCs are present with engine identifier LUK selected, perform the related G.S.I. diagnosis and repair as necessary.
- If there are still no DTCs stored with engine identifier LUK selected and the charging system appears to be inoperative, perform the following steps to reset the contactors and re-evaluate the charging system operation.
 1. Start GDS2
 2. Select the Hybrid Powertrain Control Module (HPCM).
 3. Select Control Functions
 4. Clear the HV DTCs in the BECM and HPCM. (When performing this procedure in the HPCM, disregard the SDM failure message that may occur in GDS2)
 5. Exit from GDS2
 6. Turn the ignition off for a minimum of 2 minutes to allow the High Speed LAN and Powertrain Expansion Bus to power down.
 7. Start the car and monitor the charging system voltage.

Note: If the charging system is still inoperative there may be a logic lock condition. Disconnect the 12V battery and perform a Global Capacitive Discharge and repeat steps 1 through 7.
