# Service Bulletin

**Subject:** Normal Characteristic - Radio Center Select Button Is Inoperative On ICS And/Or Touch Screen Is Inop

**Models:** 2013 Buick Encore  
With Navigation Radio (RPO UHQ)

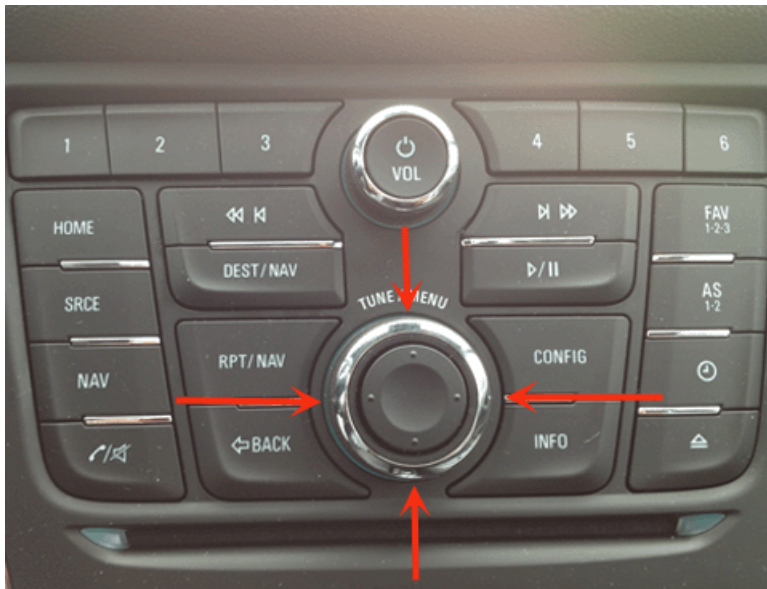
A dealer or customer may comment that the center select button on the ICS for the radio is inoperative or the touch screen is inoperative.

1. The center Joystick ONLY operates when in the Map Mode. The large chrome dial in the center of the ICS must be used to make a selection then the chrome outer edge needs to be pressed in to make the Selection. See photo below:
