Bulletin No.: PIP4972C

Service Bulletin

Subject: Allison LCT1000 Range Inhibit Or No Forward Reverse P0877 Or P2723 May Be Set

Equipped with the Allison LCT1000 Transmission RPO M74 or MW7

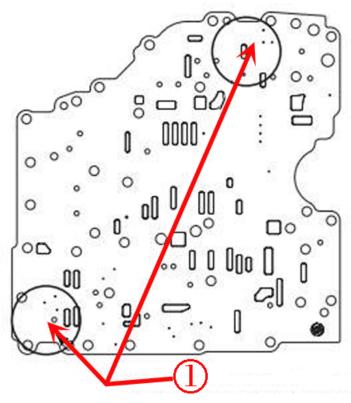
Call out 1

PCS1 feed hole - An intermittent or no reverse condition can be exhibited when the PCS1 feed is blocked along with P2723 setting.

Reverse pressure orifice - Drive range may be inhibited along with P0877 setting.

Most common areas of blockage.

Many aftermarket spin-on filters are shipped with a protective shrink-wrap packaging that may inadvertently be introduced into the transmission during filter installation; this can contribute to a condition where the valve body separator plate orifices can become plugged. Always closely inspect the separator plate for this condition anytime the valve body is removed.

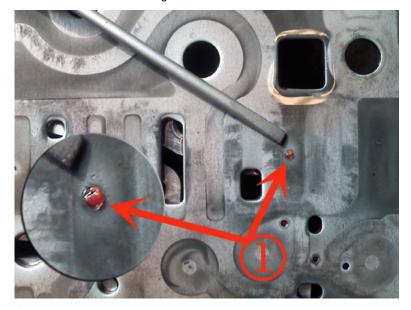
Call out 1

Example of blockage.
