# Service Bulletin

**Subject:** Allison LCT1000 Range Inhibit Or No Forward Reverse P0701 P0729 P0731 P0732 P0733 P0734 P0735 P0751 P0756 P0761 P0877 Or P2723 May Be Set

**Models:** 2011-2013 Chevrolet Silverado  
2011-2013 GMC Sierra

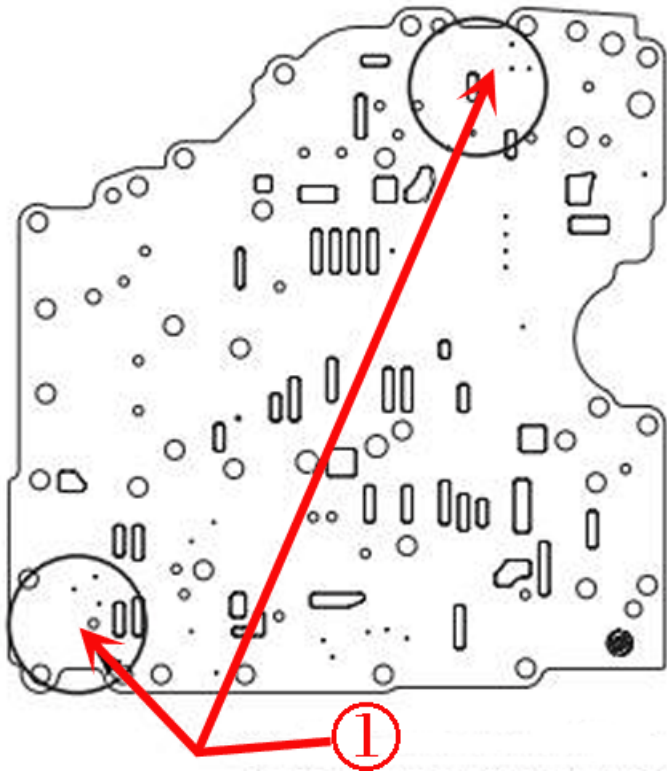
Modulated main feed orifice- P0701 P0729 P0731 P0732 P0733 P0734 P0735 P0751 P0756 P0761 may set if this orifice is blocked.

PCS1 feed hole-An intermittent or no reverse condition can be exhibited when the PCS1 feed is blocked along with P2723 setting.

Reverse pressure orifice-Drive range may be inhibited along with P0877 setting.

The most common areas of blockage are shown in the picture below.

**Note:** Low main pressure (50 psi) continuous or intermittent regardless of modulated main pressure control solenoid current may be caused by the modulated main pressure control solenoid feed orifice being blocked.

Call out 1  
Most common areas of blockage.

Always closely inspect the separator plate for this condition anytime the valve body is removed.

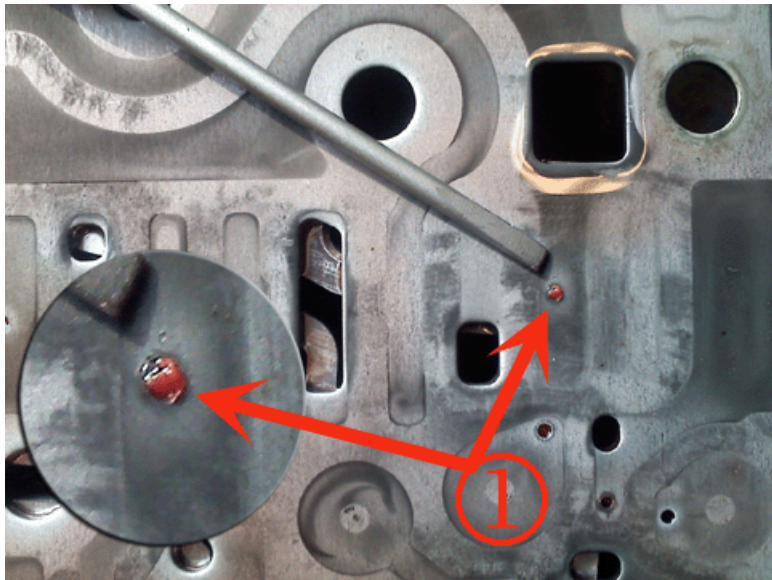
Many aftermarket spin-on filters are shipped with a protective shrink-wrap packaging that may inadvertently be introduced into the transmission during filter installation; this can contribute to a condition where the valve body separator plate orifices can become plugged.

Call out 1  
Example of blockage.
